# **A Structural Reevaluation of the Collapse of World Trade Center 7**

## **Final Report**

**INE Report 18.17**

**March 2020**

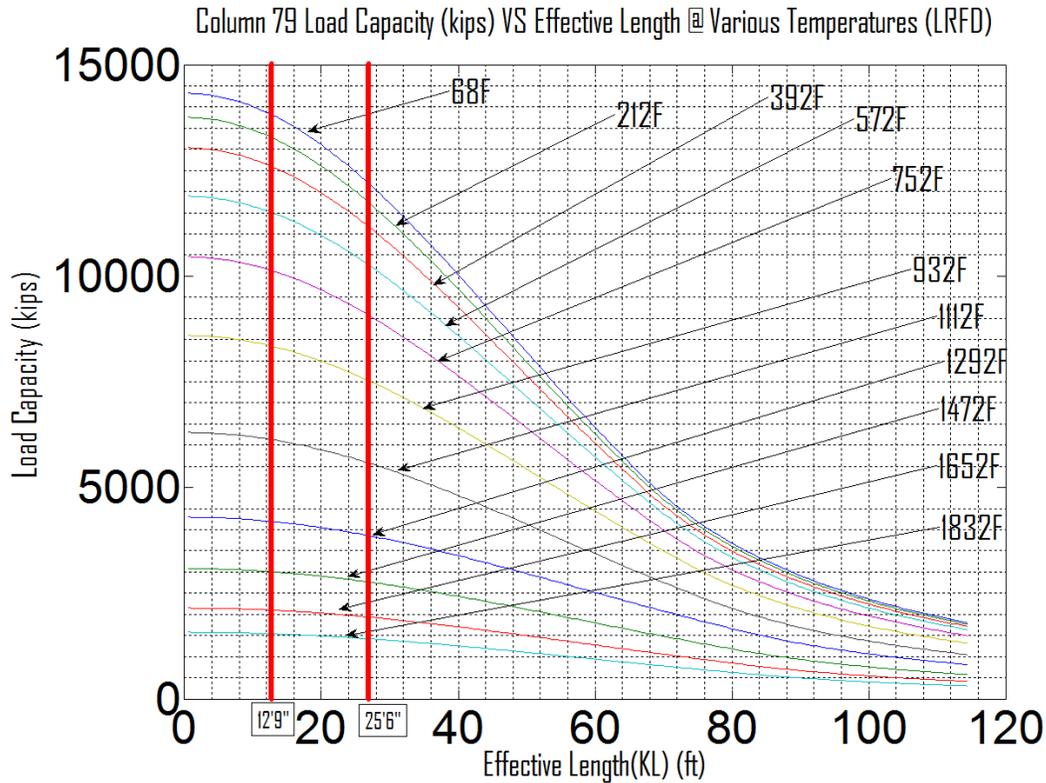
Column 79 at Floor 13 was a built-up column consisting of W14×730 and two steel plates 2 inches thick by 26 inches wide welded on the sides. Figure 2.16 shows the cross section of Column 79. Figure 2.17 shows the mechanical properties of steel against temperature (Engineering tool box, 2011). A buckling analysis was conducted for Column 79 according to the AISC Steel Construction Manual (AISC, 2011). Figure 2.18 shows the load capacity of Column 79 versus the effective length at different temperatures assuming a pinned-pinned condition. The two red lines mark the effective length of 12 feet 9 inches and 25 feet 6 inches. The two effective lengths are the single floor height and the double floor height. The loading capacity of Column 79 at double floor height (25 feet 6 inches) would be the load capacity of the column during the fire if Column 79 were to lose its support on one floor. It is clear from Figures 2.17, 2.18 and Table 2.1 that the buckling load capacity was significantly higher than the acting load over a two-story unsupported length. Thus, a buckling failure due to vertical loading and heat caused by a fire could not have occurred.

Figure 2.18 Load capacity of Column 79 versus effective length at different temperatures.

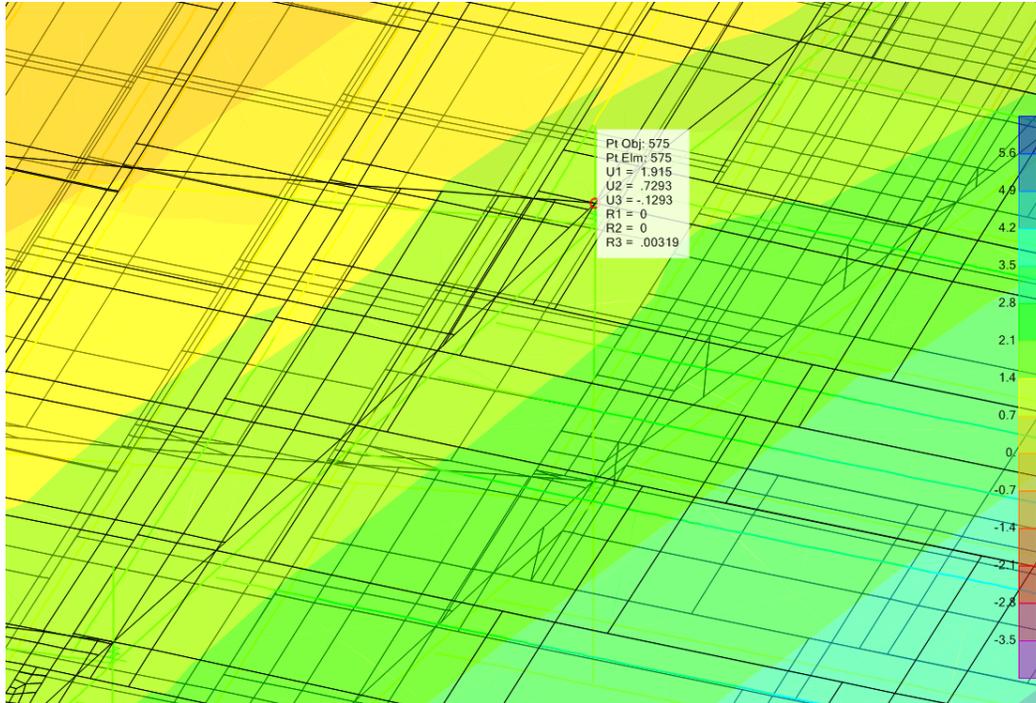
were not sufficient to displace girder A2001 to the point that it walked off its seat (the initiating failure alleged by NIST). Whereas NIST asserted that the differential westward displacement of girder A2001 relative to Column 79 was 5.5 inches and later revised its calculation to 6.25 inches, we found that the westward displacement of girder A2001 relative to Column 79 would have been less than 1 inch under the fire conditions reported by NIST.

Figure 2.59 Displacement (inches) of the floor system surrounding Column 79.

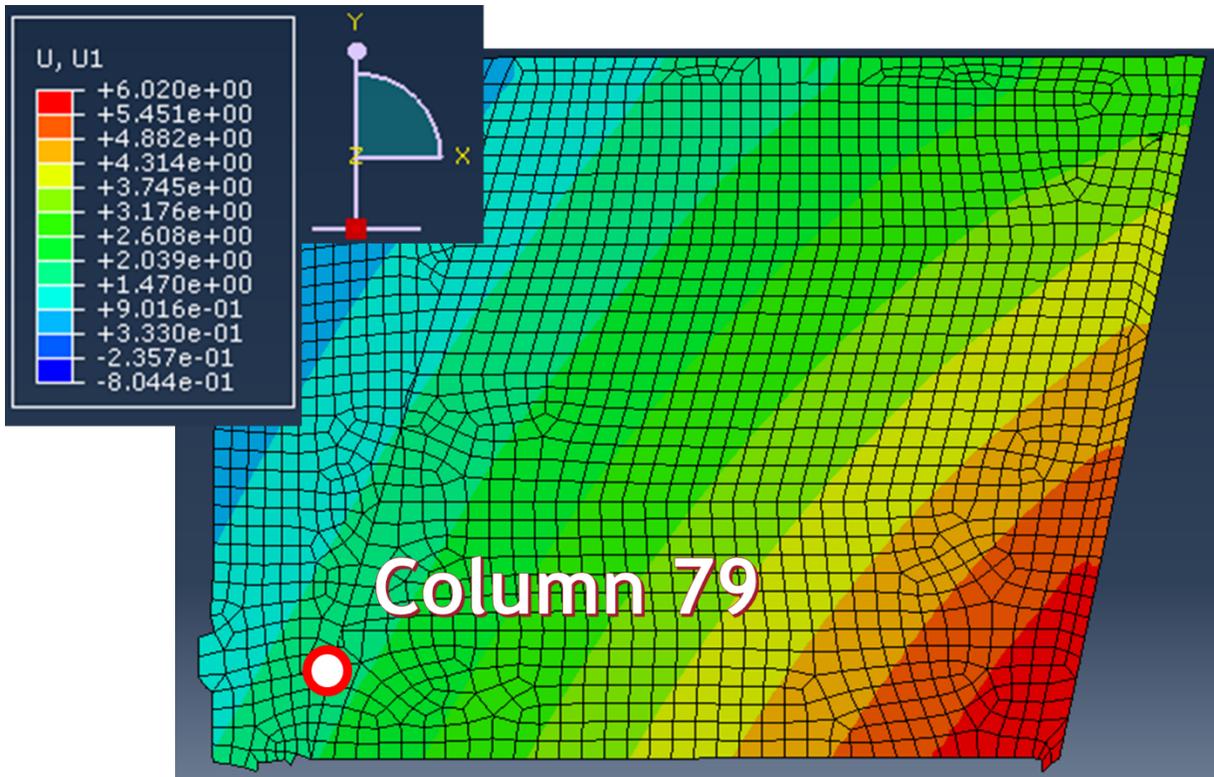
Figure 2.63 Movement (inches) in x-direction at Floor 13 around Column 79.

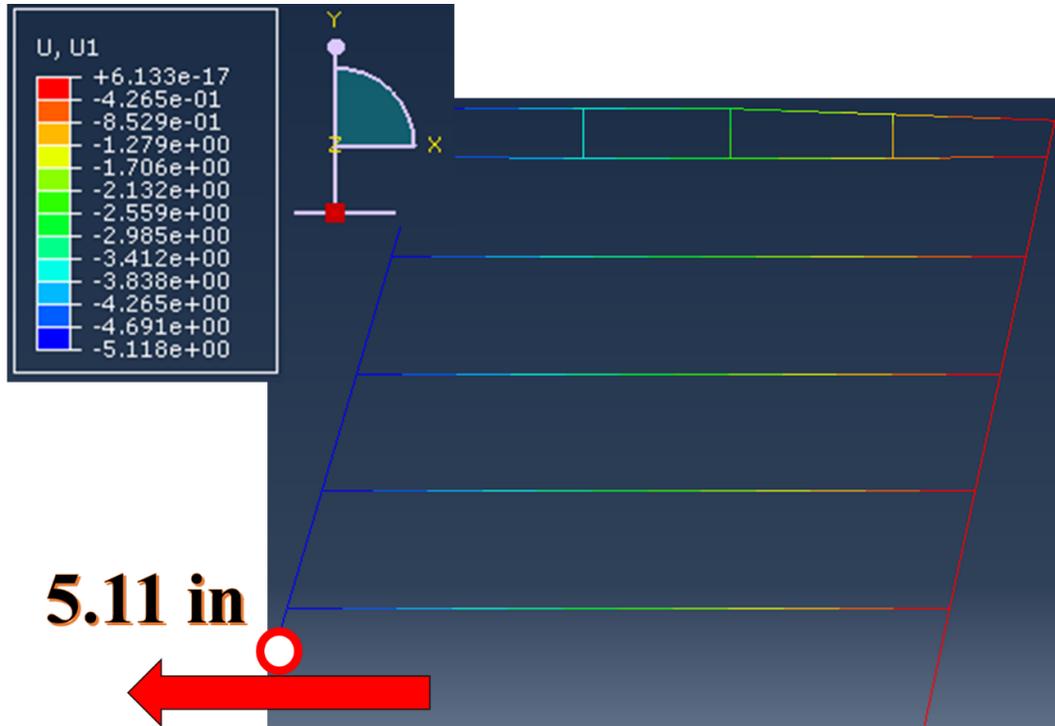
Figure 2.66 Transverse displacement at the end of A2001 using the NIST assumptions.

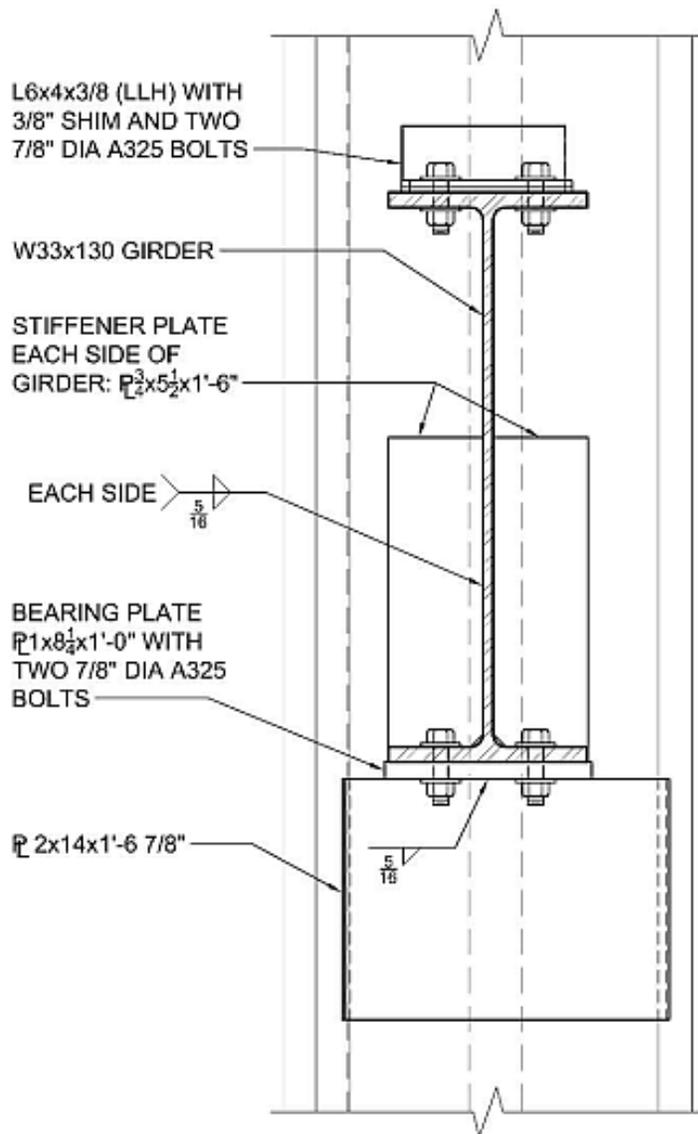
- NIST, by its own admission, did not include the partial height web stiffeners known to be on girder A2001. In addition to stiffening the web, these stiffeners significantly increase the bending resistance of the flange. In a subsequent analysis where we removed the side plate described in the previous paragraph in order to allow for further westward travel of girder A2001, we found that the stresses in the girder flange and stiffener would not be sufficient to cause the flange to fail, thus preventing the girder from walking off its seat (Section 3.2.2).

Figure 3.6 Section view at Floor 13 of Column 79 and girder A2001 seated beam connection, which shows stiffener plates on girder A2001 (Data from Frankel Steel Limited, 1985, Drawing 9114; figure prepared by Brookman, 2012).

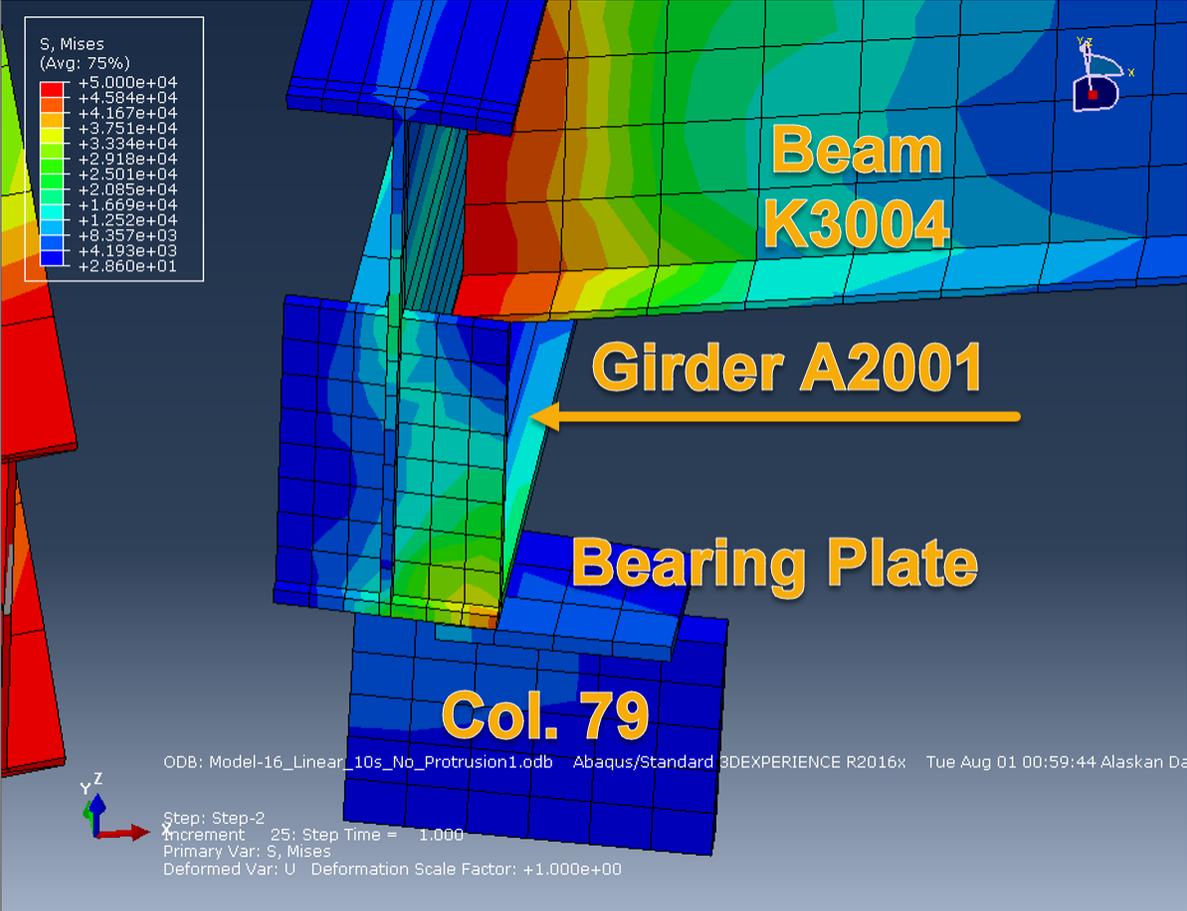
Figure 3.8 Analysis showing girder web A2001 pushed laterally past the bearing seat at Column 79. The column is removed for clarity.

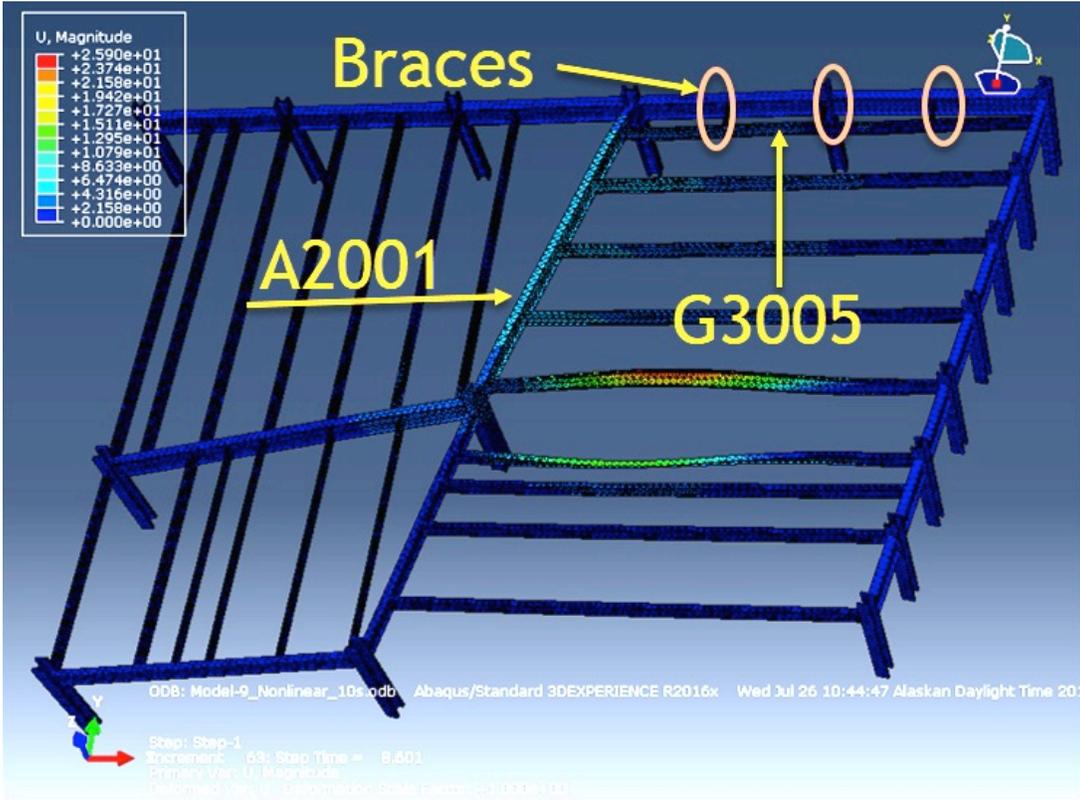
happen only when the three lateral support beams S3007, G3007, and K3007 spanning from beam G3005 to the north exterior wall are not included in the model. While these short beams are observed in some of the figures in the NIST report, they are missing from the model(s) used in the thermal and structural analysis shown in the report (Section 3.2.3).

Figure 3.11 UAF ABAQUS analysis shows beam G3005 does not buckle when braced by lateral support beams S3007, G3007 and K3007 (Frankel Steel Limited, 1985).

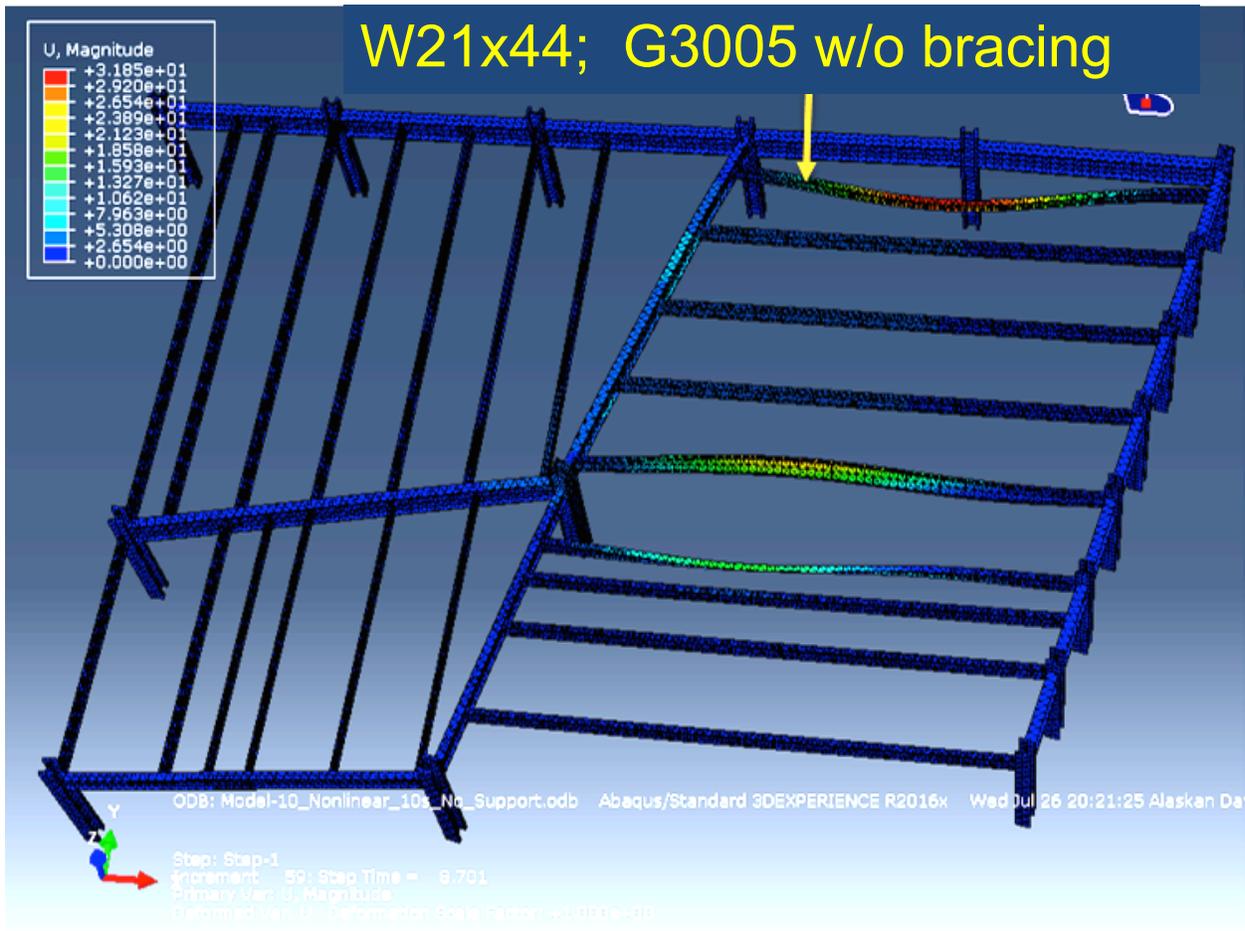
Figure 3.14 UAF analysis of the W21x44 G3005 with no lateral support beams included.

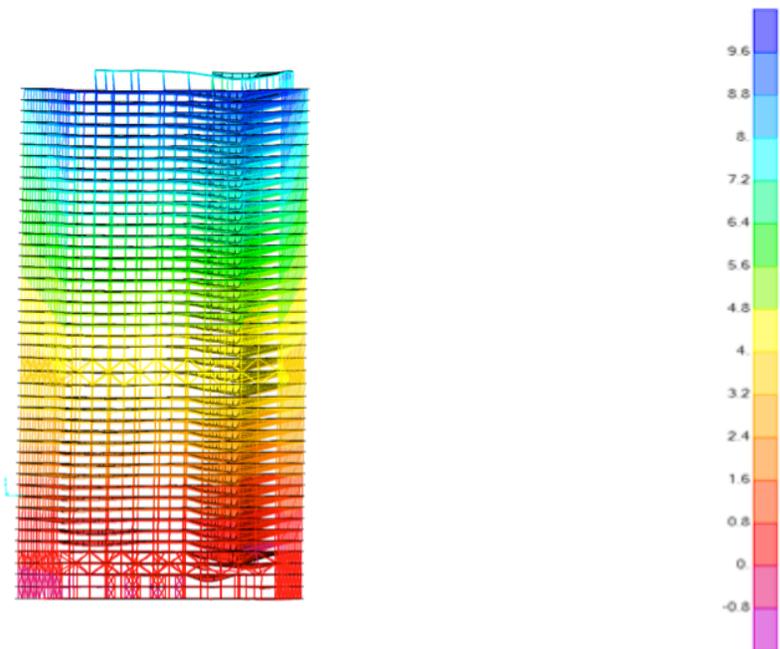
Figure 4.2 Columns 79, 80, and 81 are removed from Floor 6 to Floor 13. The key to the right is expressed in inches of movement. The building tilts to the east almost 10 inches. The penthouse does not collapse.

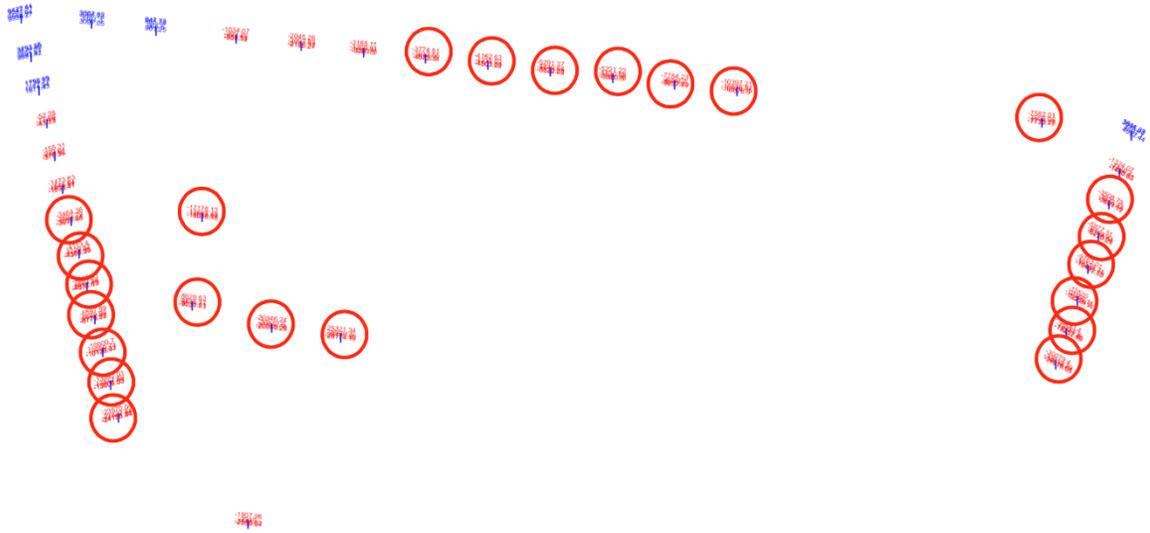
Figure 4.12 Linear static analysis results show that the failure of additional columns (shown in Figure 4.11 above) leads to the failure of the remaining core columns and many exterior columns (circled in red). The columns with blue values are in tension rather than compression, indicating the building is tipping away from those columns.

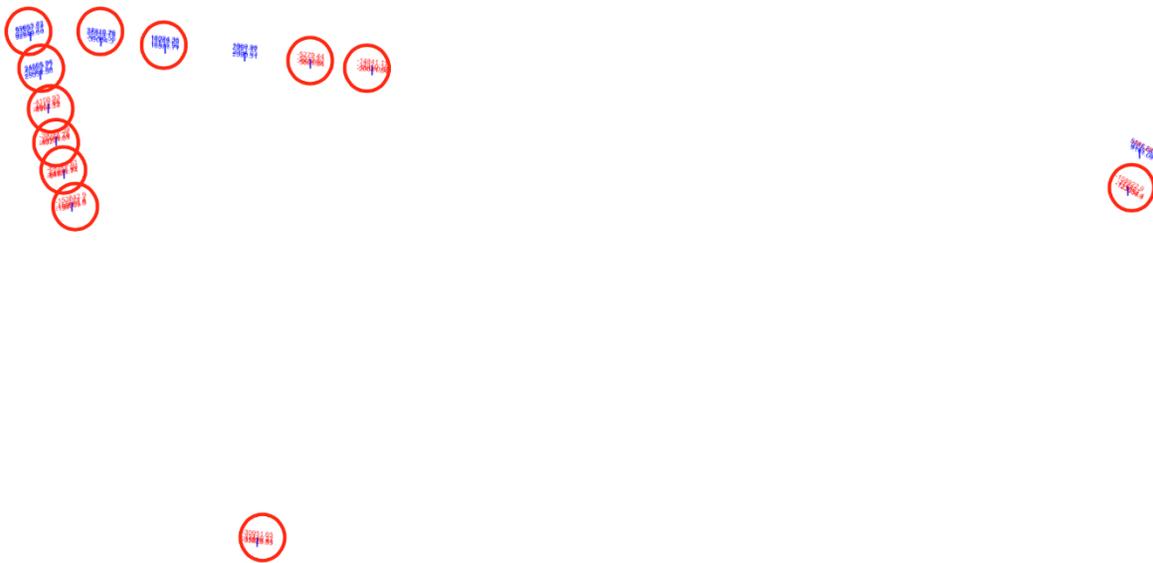
Figure 4.13 Linear static analysis results show that the failure of additional columns (shown in Figure 4.12 above) leads to the failure of nearly every remaining column (circled in red).

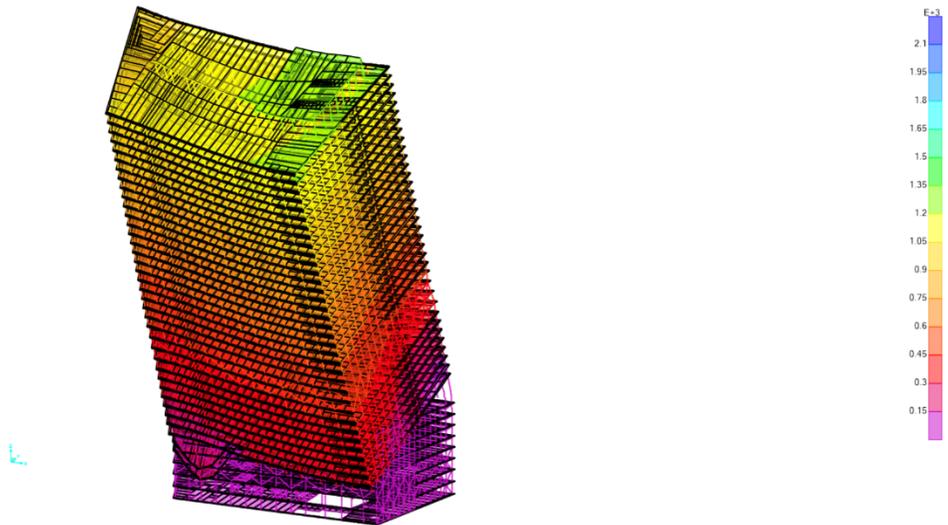
Figure 4.14 A visualization of linear static analysis, from the southeast, showing movement to the southeast when Columns 76 to 81 are removed. The movement shown is highly amplified for clarity. The actual scale of the displacements are presented to the right.

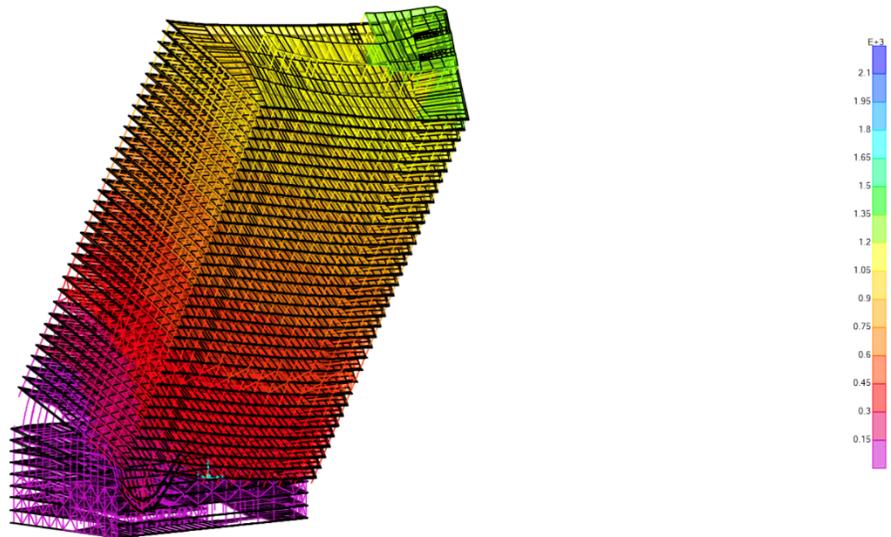
Figure 4.15 Visualization of linear static analysis, from the southwest, showing the building tipping to the southeast after the hypothetical failure of Columns 76 to 81. The movement shown is highly amplified for clarity. The actual scale of the displacements are presented to the right.

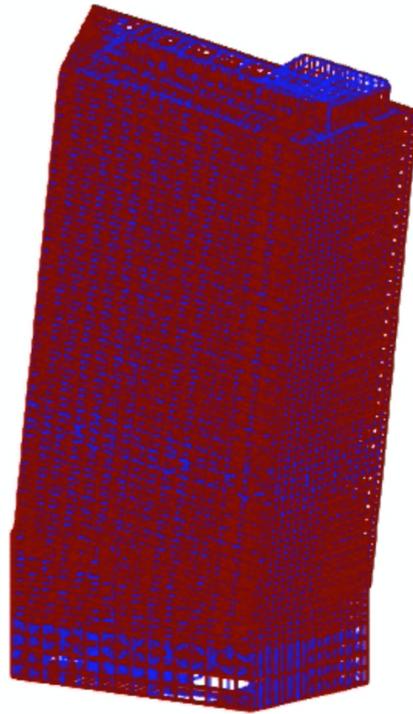
Figure 4.16 Dynamic analysis results showing the building tipping to the southeast after the hypothetical failure of Columns 76 to 81. The movement shown is highly amplified for clarity.

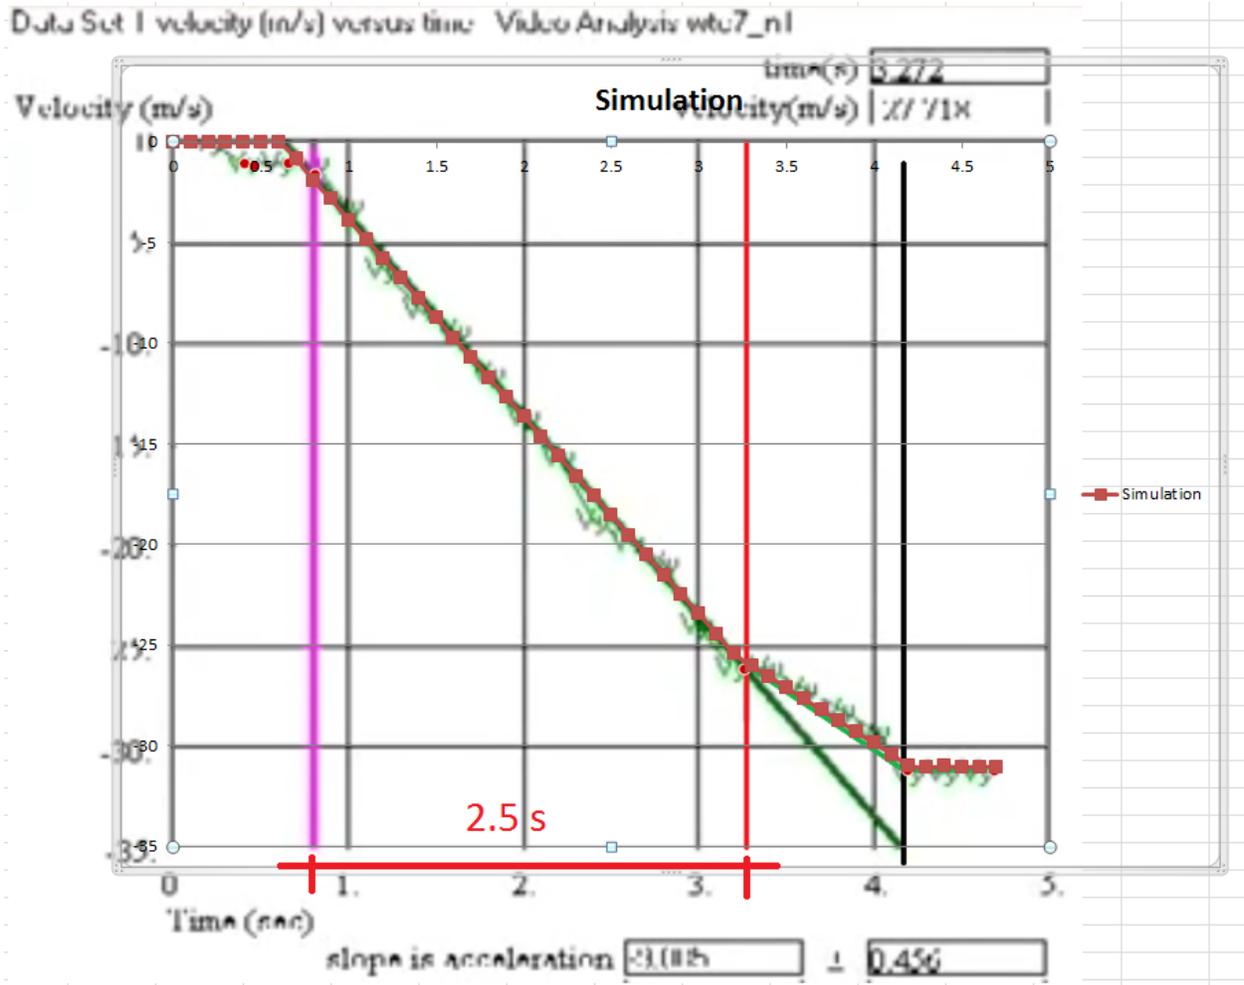
This conclusion is based primarily upon the finding that the simultaneous failure of all core columns over 8 stories followed 1.3 seconds later by the simultaneous failure of all exterior columns over 8 stories produces almost exactly the behavior observed in videos of the collapse, whereas no other sequence of failures that we simulated produced the observed behavior. We cannot completely rule out the possibility that an alternative scenario may have caused the observed collapse; however, the near-simultaneous failure of every column is the only scenario we identified that was capable of producing the observed behavior.

Figure 4.20 Velocity comparison between Chandler measurement (green plotted line) and UAF simulation (red plotted line). Bold green trend line illustrates free fall.
