# **A Structural Reevaluation of the Collapse of World Trade Center 7**

## **Final Report**

**INE Report 18.17**

**March 2020**

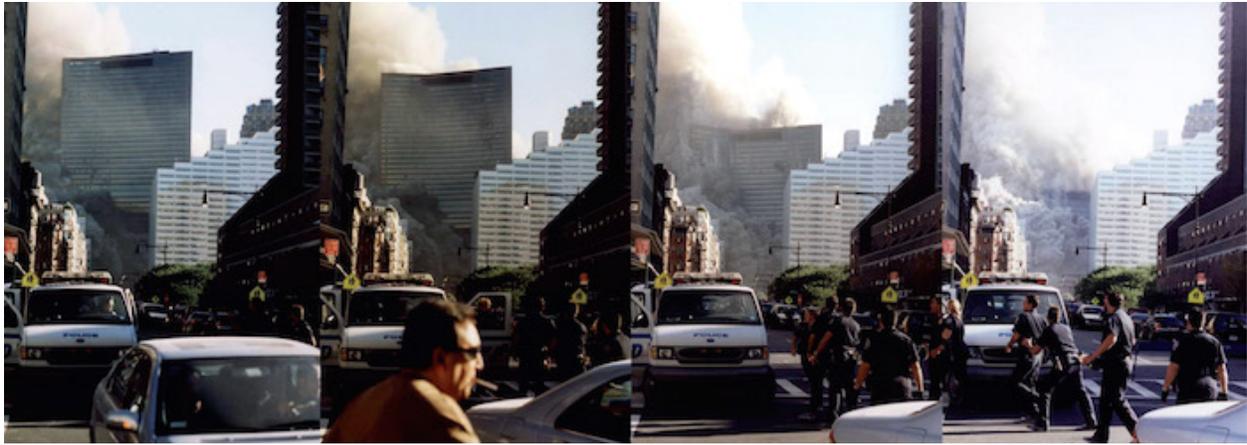
Figure 1.5 The collapse of WTC 7 at 5:20 PM (source unknown).

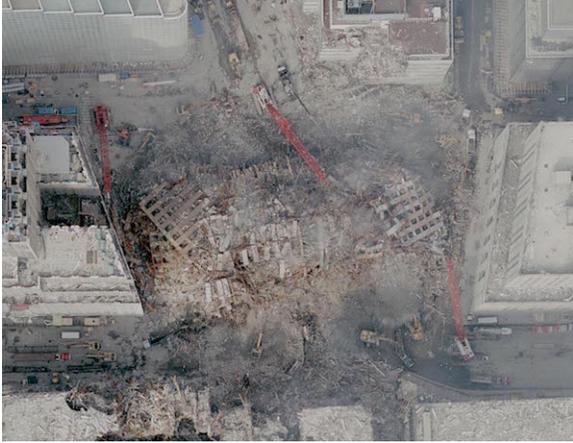
2. The debris pile of WTC 7 was contained mostly inside the building's footprint. Furthermore, it did not have large pieces of concrete flooring or intact structural framing that would be expected in a building collapse (see Figure 1.7).

Figure 1.7 WTC 7 debris pile (NOAA, September 23, 2001).

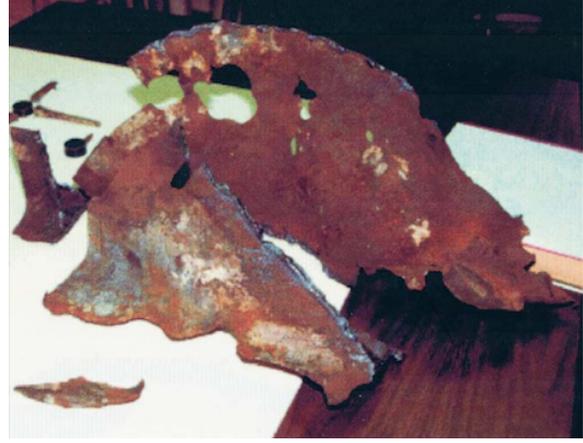
3. According to Appendix C of FEMA's May 2002 report, a steel member recovered from WTC 7 was found to have experienced corrosion due to a combination of oxidation and sulfidation at 1,000°C, resulting in the formation of a liquid eutectic (see Figure 1.8). Researchers have hypothesized that the presence of thermate, which is a form of thermite

Figure 1.8 Steel from WTC 7 that experienced oxidation and sulfidation (FEMA, 2002).

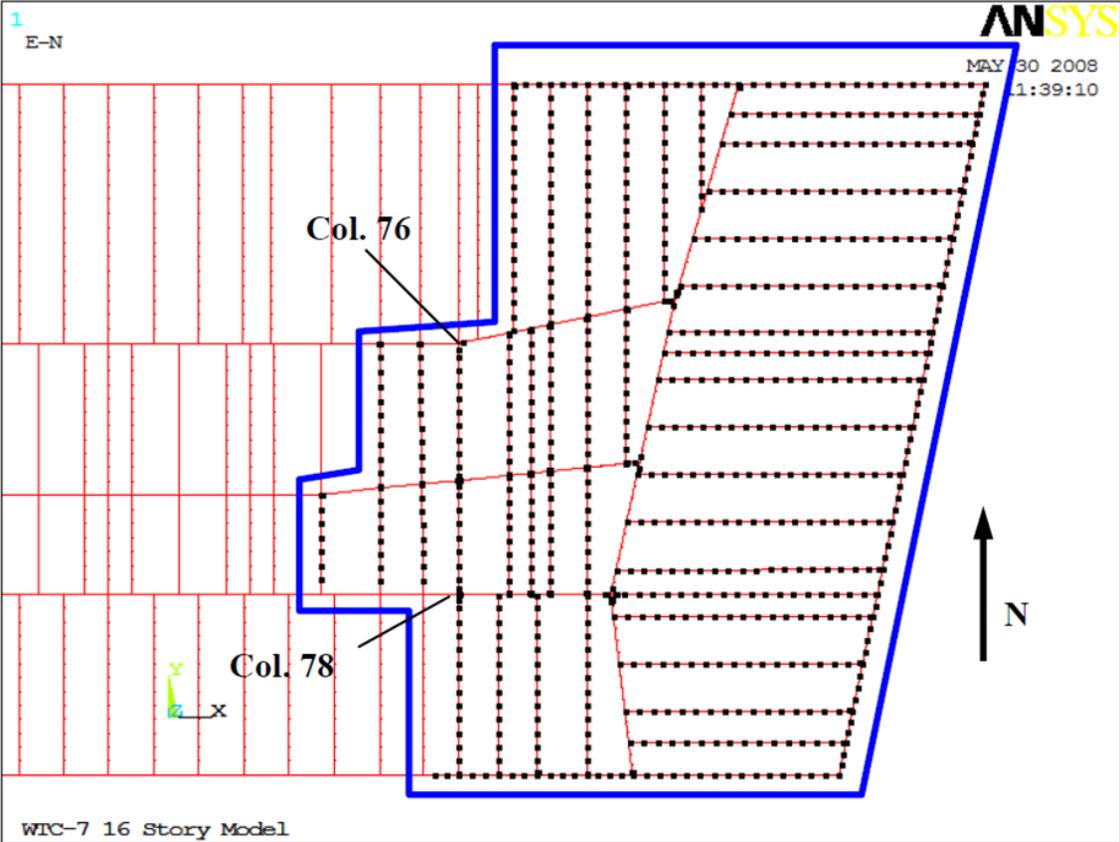
In the NIST investigation, the failures of the floor-framing connections and the shear studs were modeled with break elements on Floors 8 to 14. Outside the selected area in Figure 2.5 shown below, structural damage — such as buckling of the steel frame and crushing and

cracking of the concrete slab — was modeled over the entire floor, but connection failures were not modeled over the entire floor. Connections were also not modeled in the exterior moment frame, as no failures were observed there prior to the onset of global collapse (NIST, 2008, NCSTAR 1A).

Figure 2.5 Area of floor where connection failure was modeled by NIST

By not modeling connections in the outside frame, NIST overestimated the rigidity of the outside frame. That assumption and inconsistent modeling for the framing connections resulted in the stiffness of the east side of the building being different than that of the west side. This resulted in the stiffness being compromised across the plan of the building.

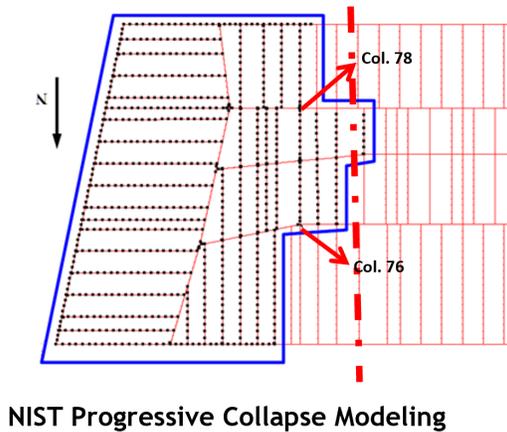
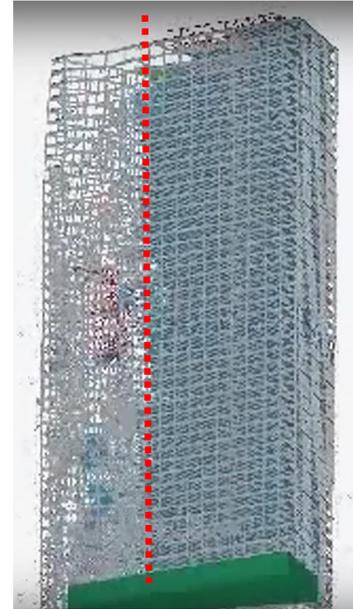
The NIST simulation of the collapse illustrated that the west side of the building acted differently from the east side. The structural response to failure would more closely resemble the actual collapse if the connections had been accounted for throughout the structural frame. By not modeling the connection failures outside the selected area shown in Figure 2.5 above, NIST appears to have reduced the stiffness in the area outside the selected area and separated its progressive collapse simulation into two parts (see Figure 2.6).

**Connections were not modeled; outside selected blue space.**

Figure 2.6 Progressive collapse separated into two parts.

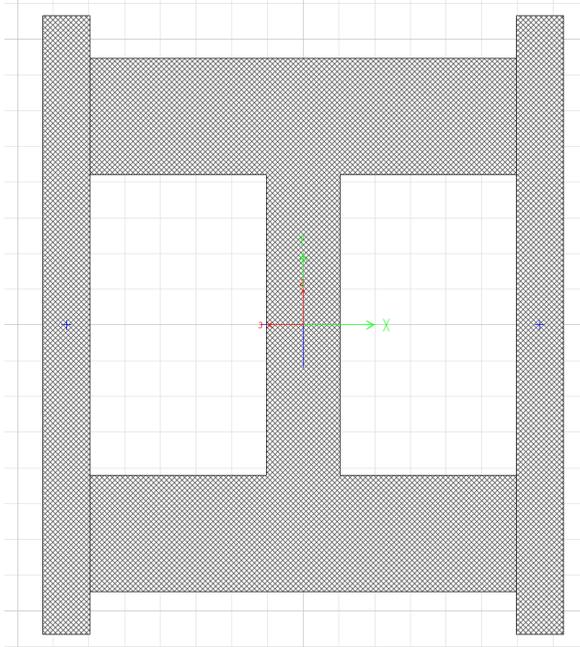
Column 79 at Floor 13 was a built-up column consisting of W14×730 and two steel plates 2 inches thick by 26 inches wide welded on the sides. Figure 2.16 shows the cross section of Column 79. Figure 2.17 shows the mechanical properties of steel against temperature (Engineering tool box, 2011). A buckling analysis was conducted for Column 79 according to the AISC Steel Construction Manual (AISC, 2011). Figure 2.18 shows the load capacity of Column 79 versus the effective length at different temperatures assuming a pinned-pinned condition. The two red lines mark the effective length of 12 feet 9 inches and 25 feet 6 inches. The two effective lengths are the single floor height and the double floor height. The loading capacity of Column 79 at double floor height (25 feet 6 inches) would be the load capacity of the column during the fire if Column 79 were to lose its support on one floor. It is clear from Figures 2.17, 2.18 and Table 2.1 that the buckling load capacity was significantly higher than the acting load over a two-story unsupported length. Thus, a buckling failure due to vertical loading and heat caused by a fire could not have occurred.

Figure 2.16 Cross section of Column 79.

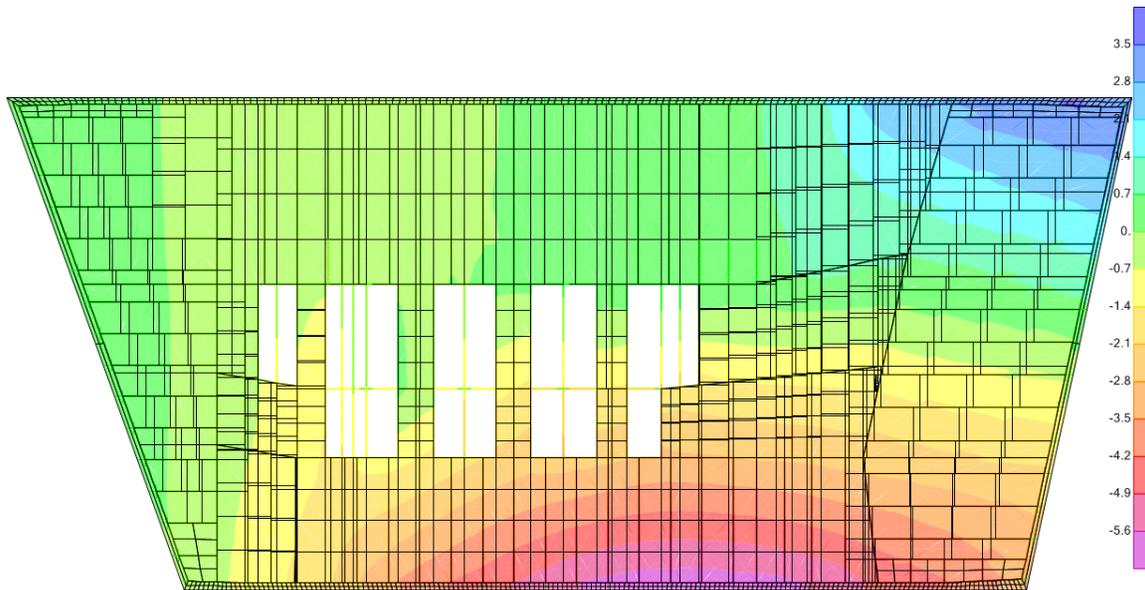
Figure 2.58 Displacement (inches) of Floor 13 in the south-north direction (in-the plane of the floor)

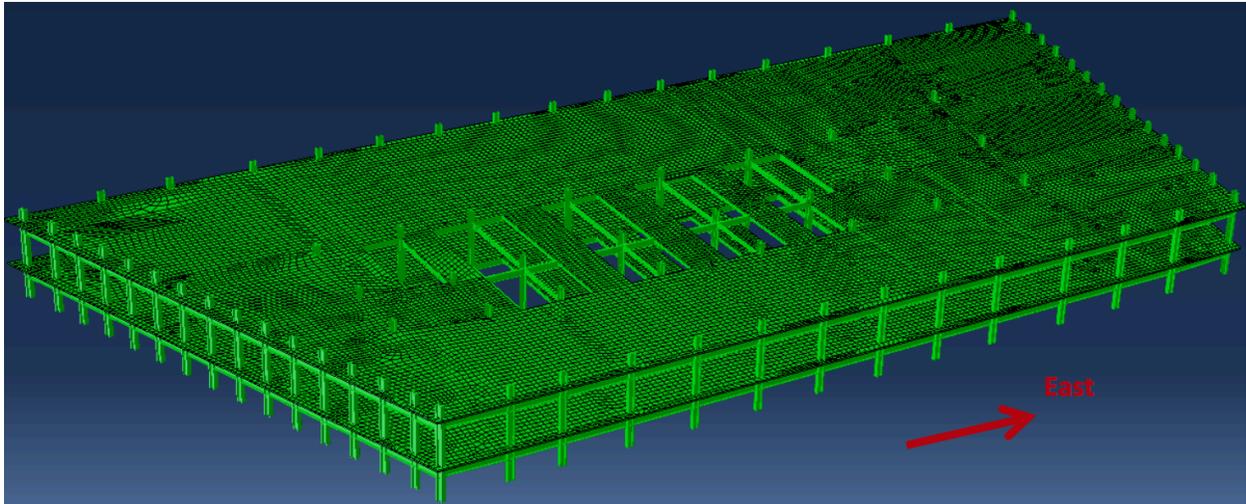
Figure 2.60 ABAQUS Model for Floors 12 and 13.

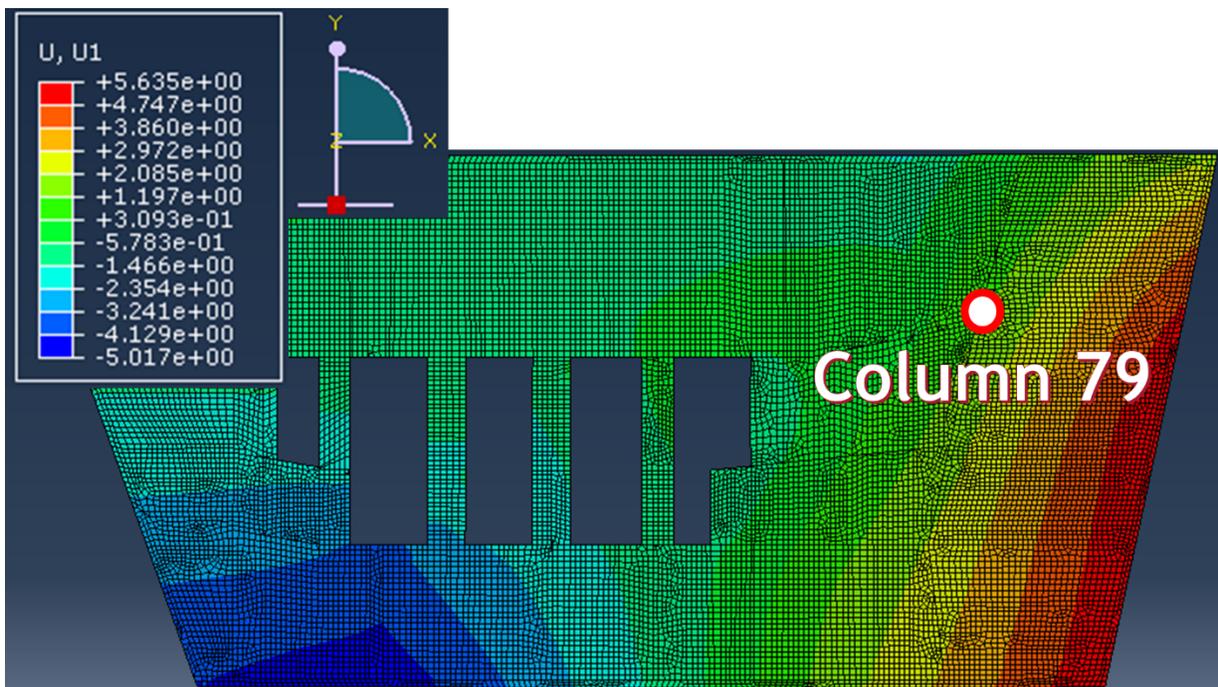
Figure 2.61 Movement (inches) in x-direction at Floor 12.

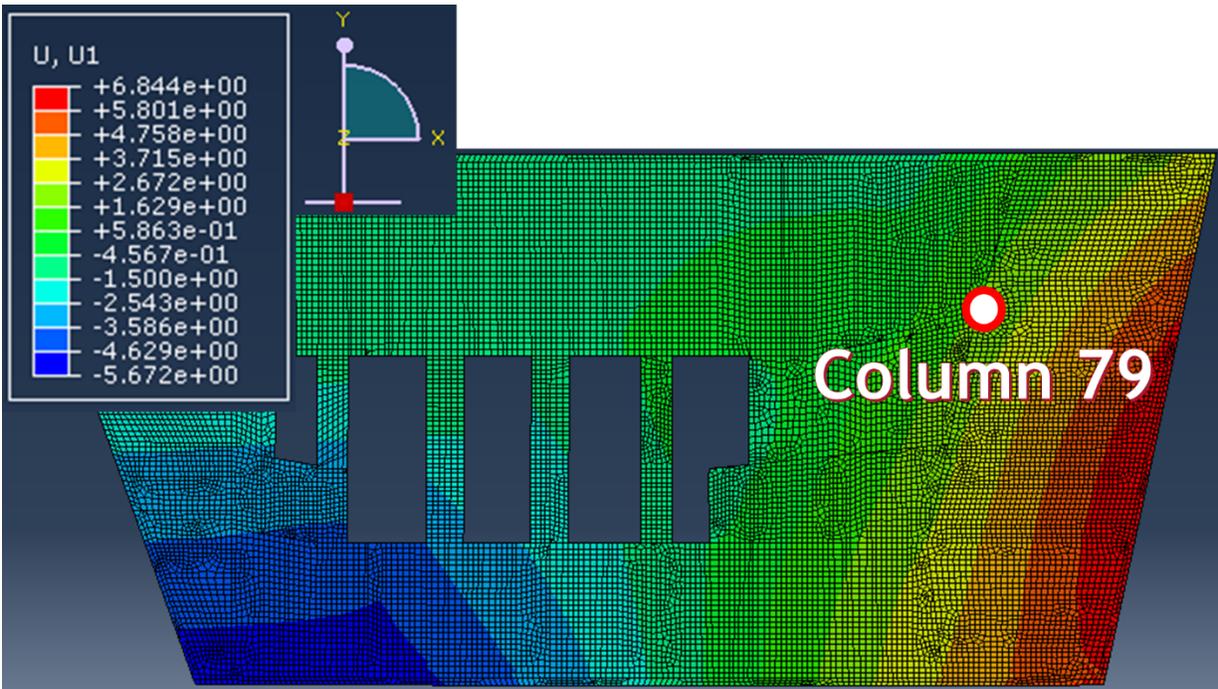
Figure 2.62 Movement (inches) in x-direction at Floor 13.

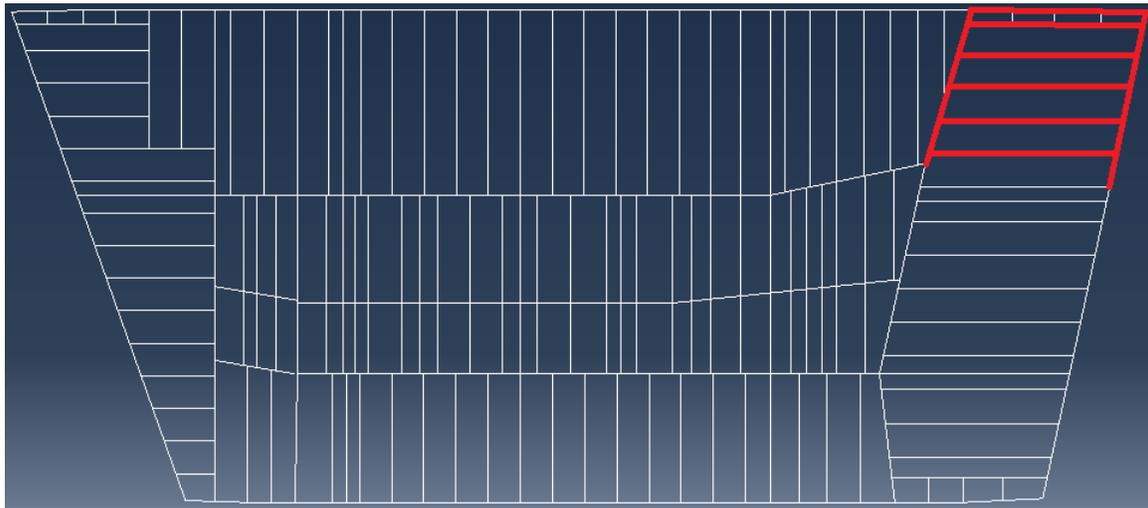
Subsequently, we studied the relative movement between Column 79 and girder A2001 in the worst-case condition to identify the maximum relative displacement at this connection in a higher temperature environment and without restriction from other frames, columns, and the deck. The part of the Floor 13 frame we examined is shown in red in Figure 2.64.

Figure 2.64 The part of the Floor 13 frame we examined is shown in red.

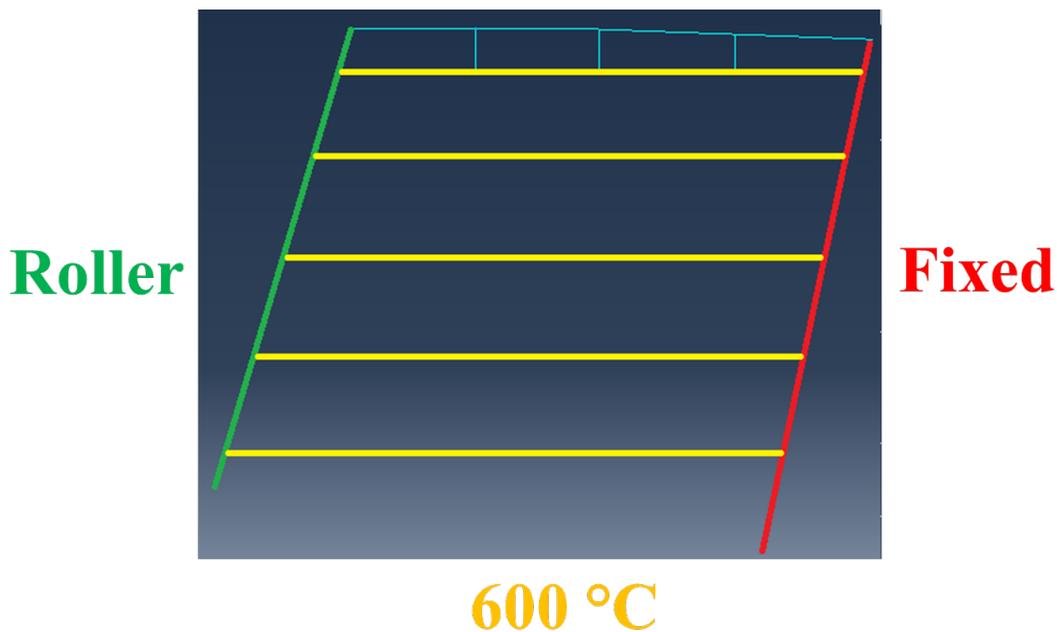
The boundary conditions reported by NIST and the assigned temperature distribution are shown in Figure 2.65 below. The concrete deck was not included in this model to ensure free expansion of the steel frame. The assigned temperature is also higher than the expected fire condition.

Figure 2.65 Local frame boundary conditions reported by NIST.

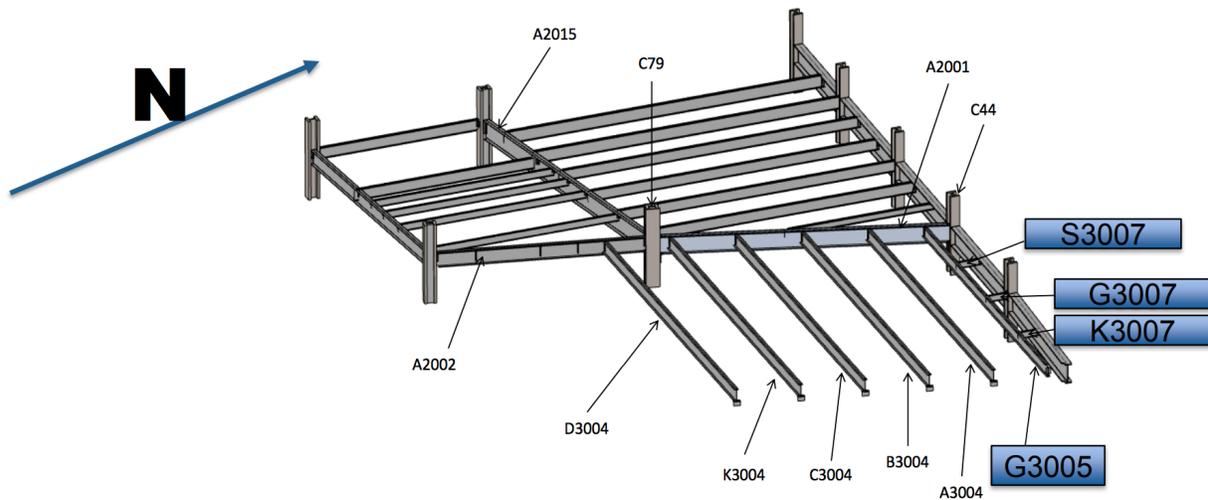
Figure 3.1 Member identification for the finite element analyses discussed below.

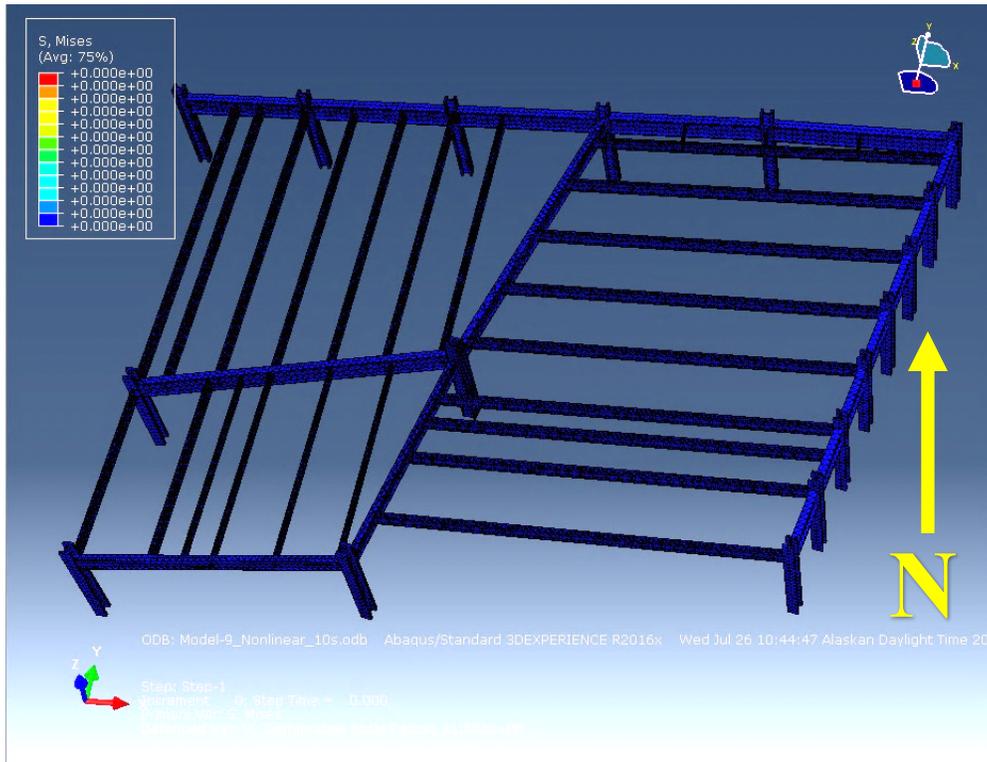
A solid model (as opposed to wire elements) of the structural members in the northeast corner of Floor 13 was generated using ABAQUS (see Figures 3.1 and 3.2). The model consisted of 49,270 nodes and 24,536 elements. A finite element analysis was performed with the aim of replicating the results reported by NIST. Namely, the result of NIST's analysis is that girder A2001 was pushed or rocked off its seats at Columns 44 and 79, and this initiated the total collapse of the building.

Figure 3.2 ABAQUS Solid model at northeast corner of Floor 13.

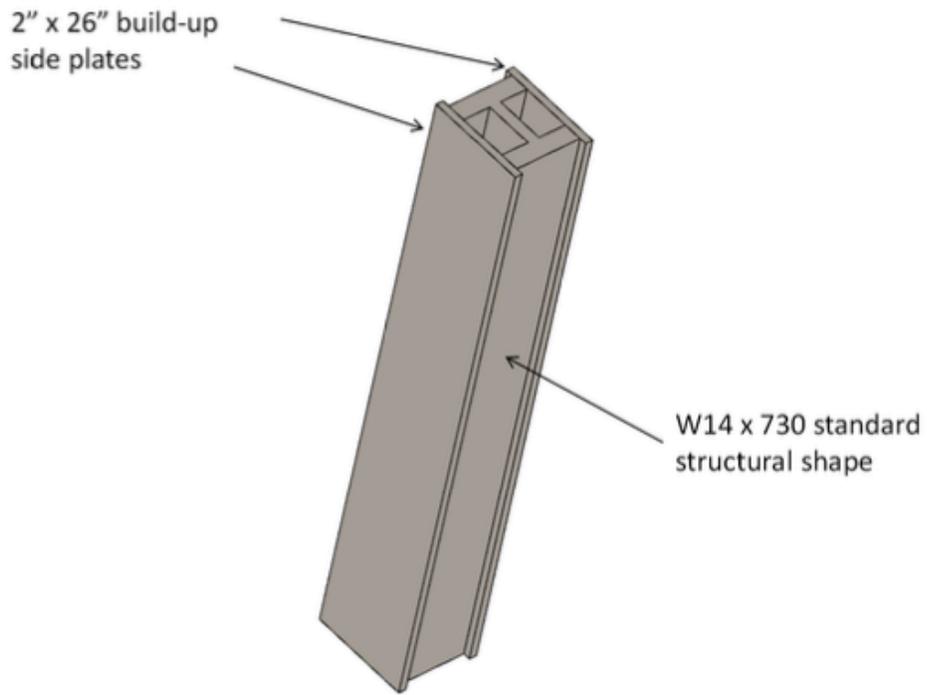
Figure 3.3 shows the built-up configuration of Column 79 with its protruding side plates. Using the assumptions made by NIST, we analyzed the thermal response of Floor 13.

Figure 3.3 Column 79 section showing side plates welded to a W14x730.

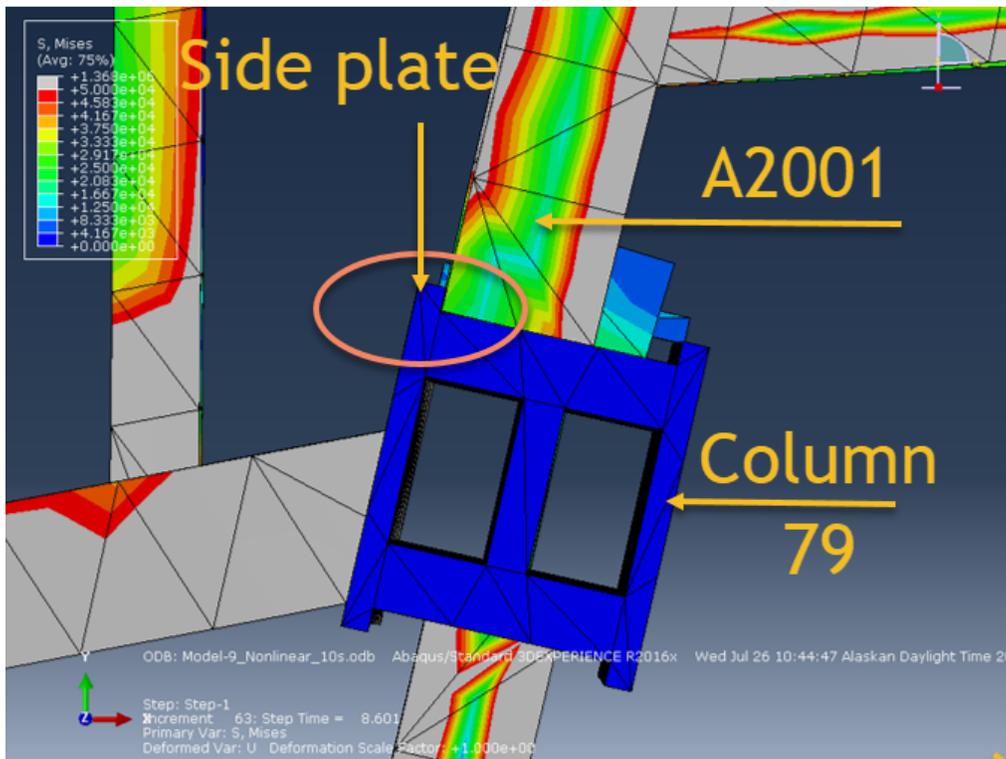
First, we found that when girder A2001 is heated, it expands axially towards column 79, such that it becomes trapped behind the side plate on the western side of Column 79 as it is pushed to the west by thermally expanded beams K3004, C3004, B3004, A3004, and G3005 (see Figures 3.1 and 3.4).

Figure 3.4 Plan view showing girder A2001 trapped by the Column 79 side plate.

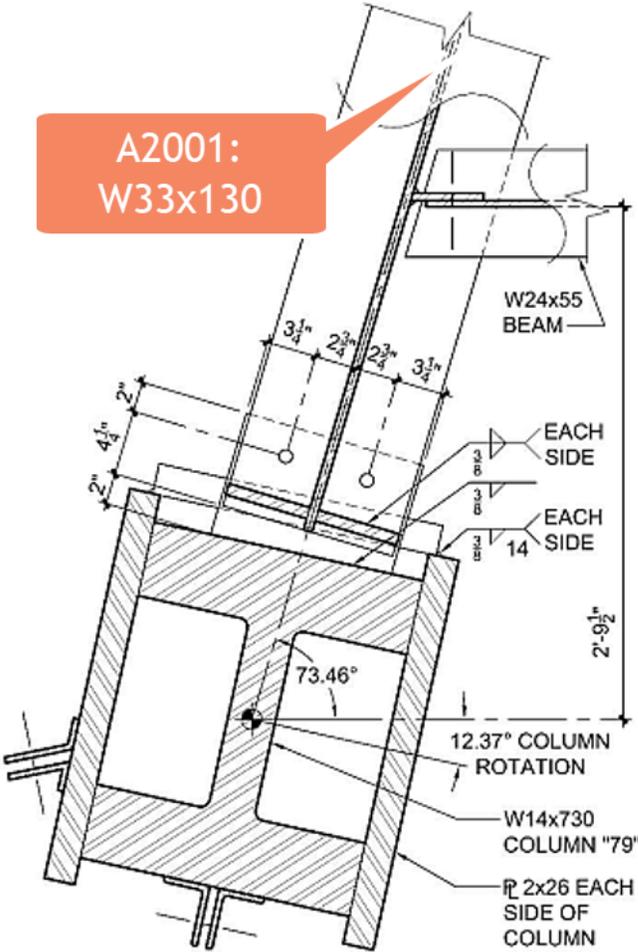
Figure 3.5 shows the girder bearing seat at Column 79 is 12 inches wide. The flange width for W33 x 130 girder A2001 is 11.510 inches wide and centered on the seat; its web is 0.580 inches thick. This would require a lateral travel distance of 6.290 inches for the web to be beyond the seat. However, the distance between the column side plates is 17.89 inches. The girder and bearing seat are slightly off center to the east, with just 3.678 inches between the girder's western edge and Column 79's western side plate. Thus, the side plate prevents the girder's web from traveling beyond the bearing seat.

Given that the Column 79 side plate prevents the girder's web from traveling beyond the bearing seat, it appears that the structural analysis performed by NIST either minimized the side plate protrusion on Column 79 (nominally 1.79 inches) or ignored it altogether.

Figure 3.5 Plan View for Floor 13 at Column 79 and girder A2001 seat connection (Data from Frankel Steel Limited, 1985, Drawing 9114; figure prepared by Brookman, 2012).

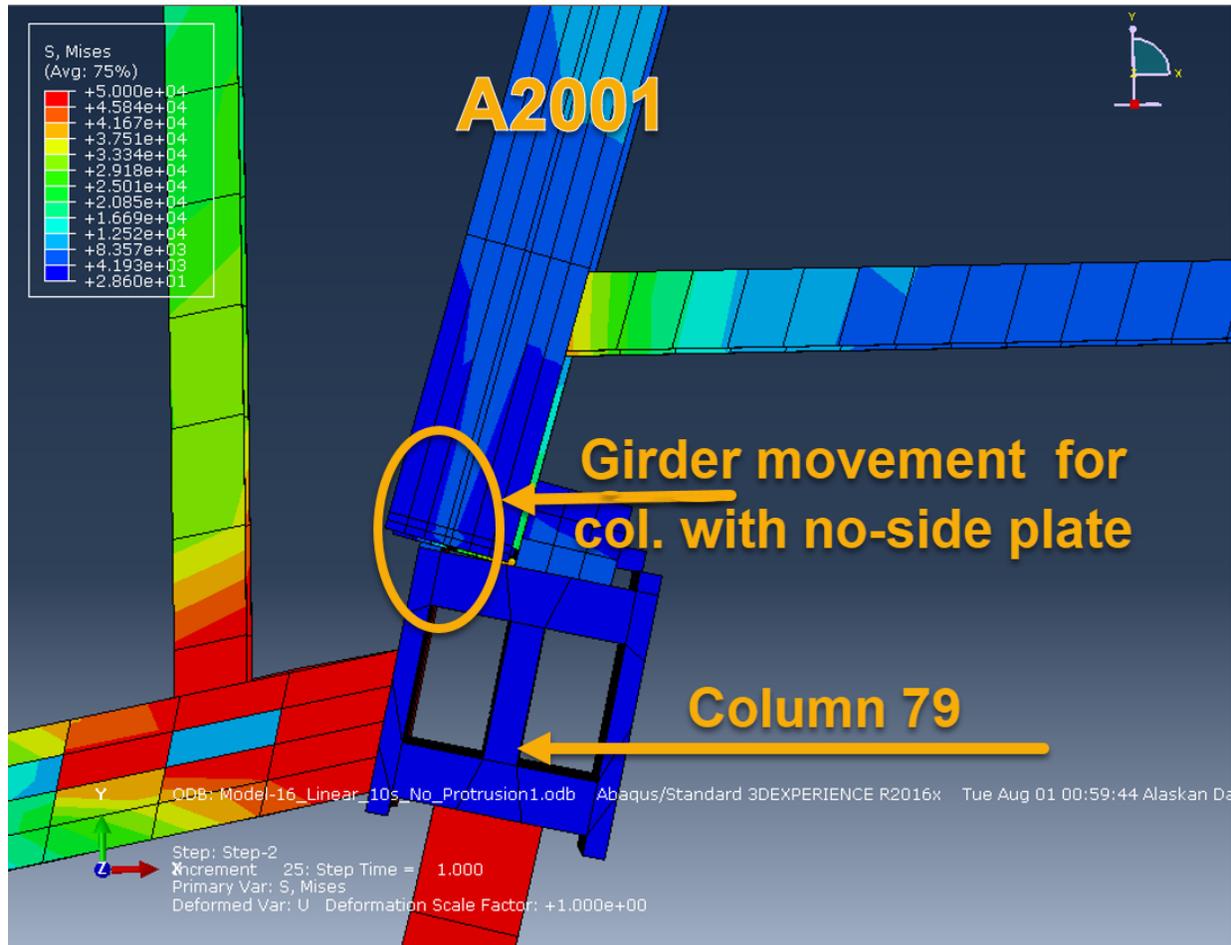
A separate model was generated to determine what would happen if girder A2001 were able to somehow move past the Column 79 western side plate. This model removed the side plate protrusion that we found in our previous analysis would interfere with the girder's lateral travel. The results are shown in Figures 3.7 and 3.8.

To perform this analysis, the coefficient of thermal expansion of the steel used for beams K3004, C3004, B3004, and A3004 was increased by approximately 40% to  $11.5 \times 10^{-6}$  in/in/°F

to ensure the girder's web moved a significant distance beyond the seat. This modification to the modeling parameters underscores the fact that under a realistic assumption of the coefficient of thermal expansion, beams K3004, C3004, B3004, and A3004 would not expand far enough to push the girder's web beyond its seat.

Figure 3.7 Plan view shows girder A2001 being pushed laterally past notched western side plate.

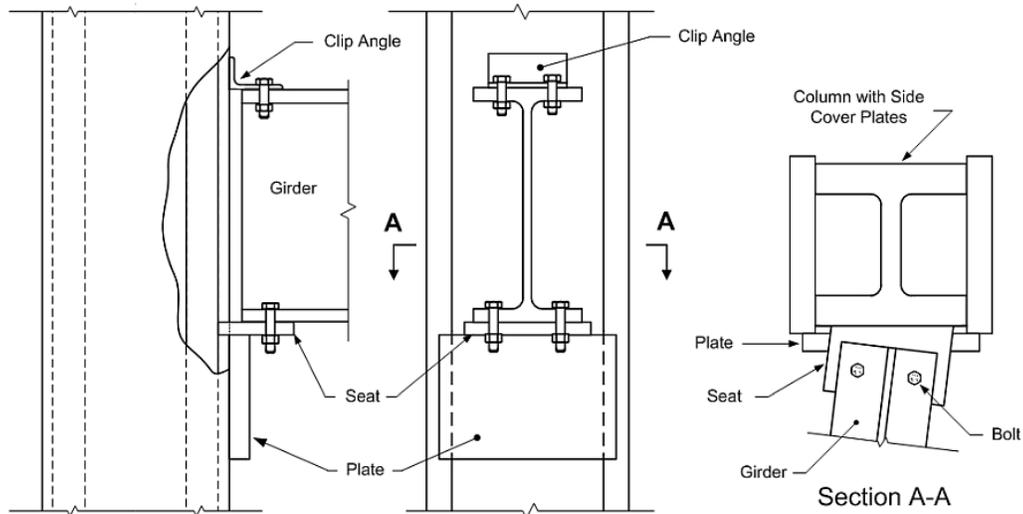
Figures 3.9 and 3.10 below, which are from the NIST report, show that the NIST report’s drawing and analysis figures omit these web stiffeners. Figures 3. 5 and 3.6 show the actual configuration.

Figure 3.9 Drawing of Column 79 and girder A2001 seated beam connection shown in Figure 8-21 of the NIST report.

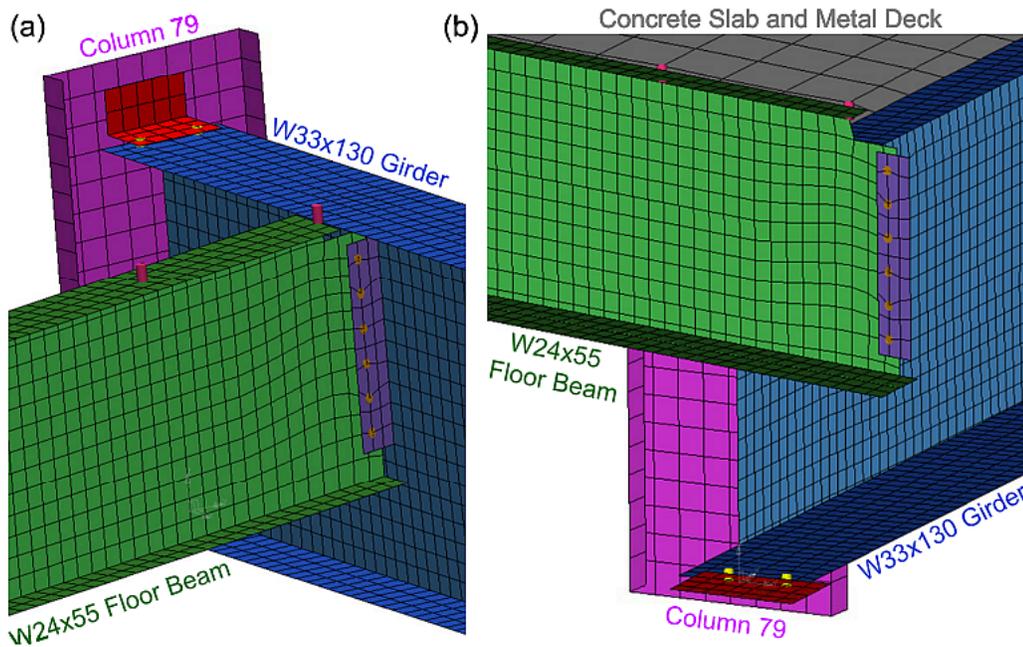
Figure 3.10 Figure 8-23 of the NIST report showing NIST's finite element analysis of the Column 79 and girder A2001 seated beam connection.

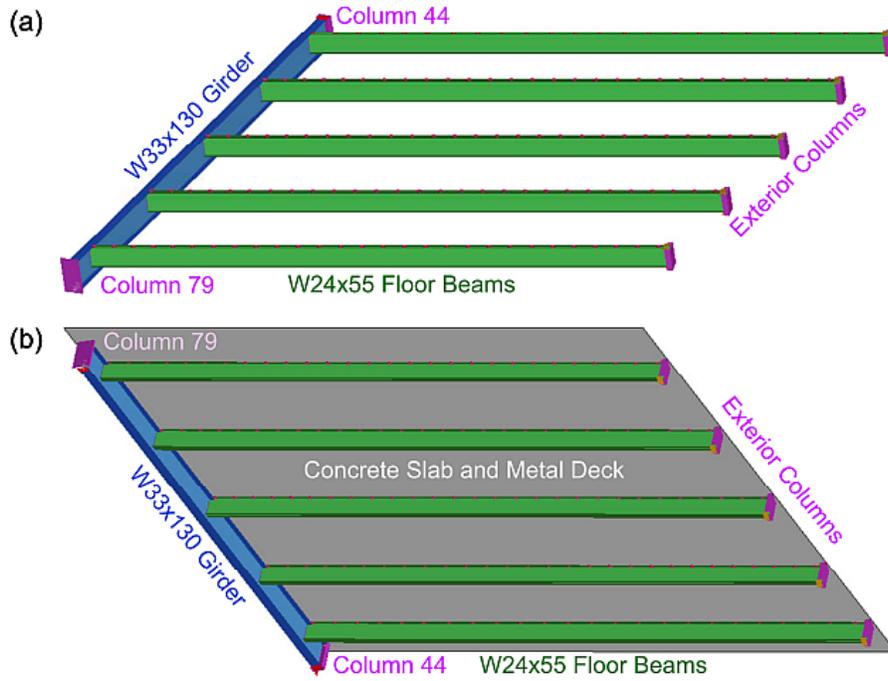
floor system was heated. The NIST report posits that beam G3005 buckled because its thermal expansion was restrained by girder A2001. Our analysis found that this can only happen when the three lateral support beams S3007, G3007, and K3007 spanning from beam G3005 to the north exterior wall are not included in the model. While these short beams are observed in some of the figures in the NIST report, they are missing from the model(s) used in the thermal and structural analyses shown in the report. It is important to realize that the lateral support beams have a significant effect and therefore should not have been omitted from the model(s).

Figure 3.12 Figure 8-22 in the NIST report shows model for girder A2001 and five beams to the east of it with no lateral bracing for beam G3005 (NIST, 2008, NCSTAR 1-9, Vol. 1, Page 350).

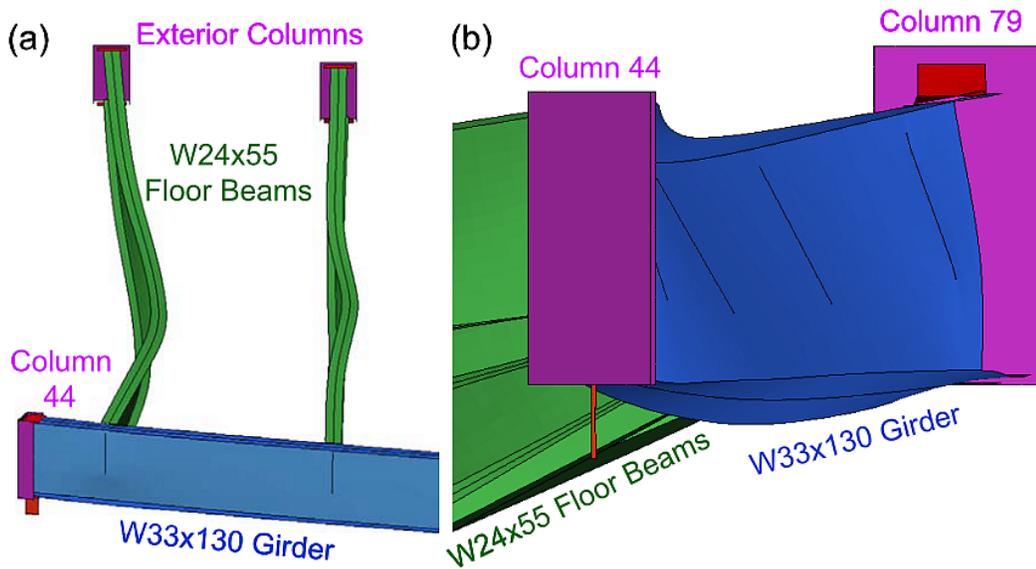
Figure 3.13 Figure 8-27 of the NIST report shows results of a finite element analysis where lateral support beams connecting to G3005 were not included (NIST, 2008, NCSTAR 1-9, Vol. 1, Page 354).

When the NIST constraints are followed, our analysis showed that beams D3004 and K3004 would have also buckled (see Figures 3.11 to 3.14). The NIST results were based upon erroneously selected boundary conditions, wherein NIST assumed the east exterior wall was extremely stiff and acted as a fixed restraint against thermal movements. As discussed previously, this was not the case.

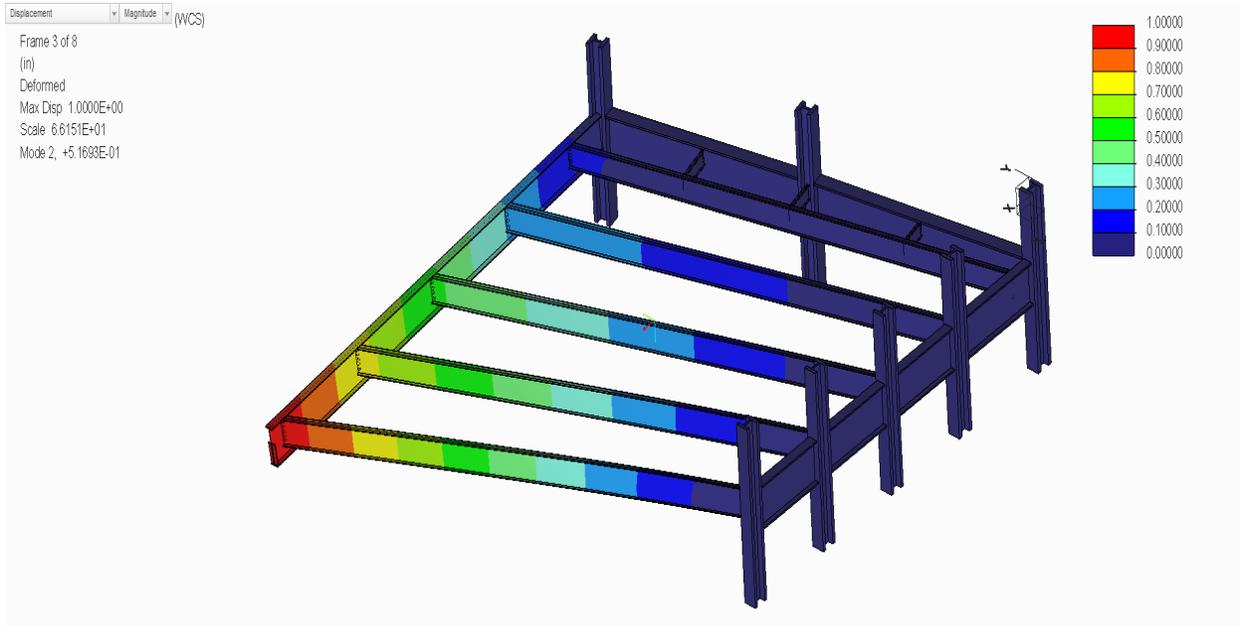
To determine the stiffness of the falling Floor 13 beam and girder assembly, a finite element modal analysis was performed with the assembly constrained at the north and east exterior walls and the girder sitting on its bearing seat at Column 44 with the bolts at the girder seat broken there. The results are shown in Figure 3.15. The first mode of 22 Hz involved only the beams moving in a transverse direction and was not relevant. The second mode of 0.52 Hz involved the participation of the entire beam and girder assembly in the vertical direction and was relevant.

Figure 3.15 The relevant 0.52 Hz mode of the falling beam and girder assembly.

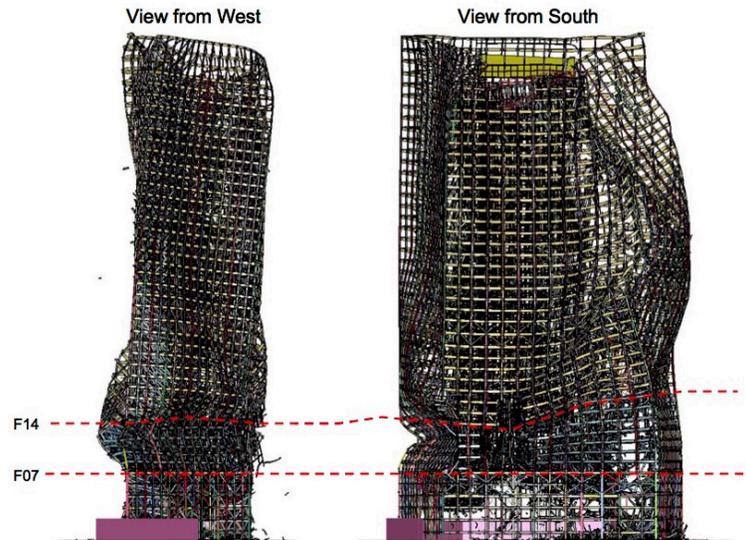
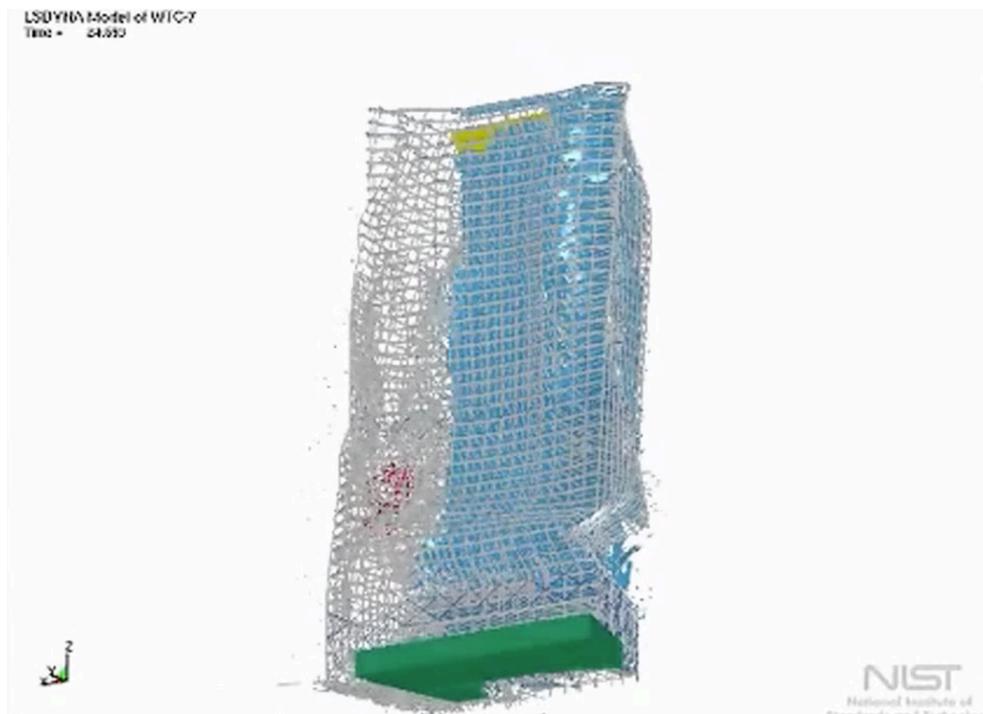
During our nonlinear connection study (Section 2.1.3.2), wherein we examined NIST's modeling of WTC 7's structural connections and its effect on NIST's progressive collapse simulation, we also observed that NIST's progressive collapse simulation did not closely resemble the observed collapse. While NIST's progressive collapse simulation does show the three key features listed above, it also predicts significant differential movements in the exterior, both before and during the fall of the roofline, that were not observed in the video (see Figures 4.1a and 4.1b). Such differential movements in the exterior would be extremely likely to have caused window breakage, cracking of the façade, and exterior deformation, none of which were observed. A major goal of our analysis was to identify failure mechanisms that would predict the minimal differential movement of the exterior seen in videos of the collapse. However, it should be noted that after the east penthouse collapse, window breakage did occur for 12 to 15 floors down from the top of the building under the penthouse. This was most likely caused by shock

Figure 4.1(a) Illustration of NIST's progressive collapse simulation showing significant differential movements in the exterior (NIST NCSTAR 1-9).

Figure 4.1(b) NIST's progressive collapse simulation showing significant differential movements in the exterior (NIST NCSTAR 1A).

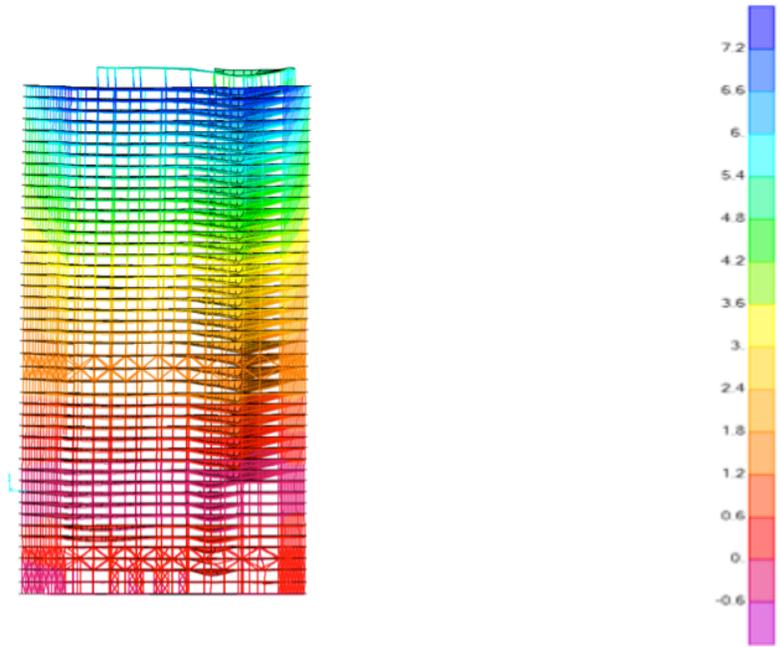
Figure 4.3 Columns 79, 80, and 81 are removed from Floor 13 to Floor 21. The building tilts to the east 7.2 inches. The penthouse does not collapse.

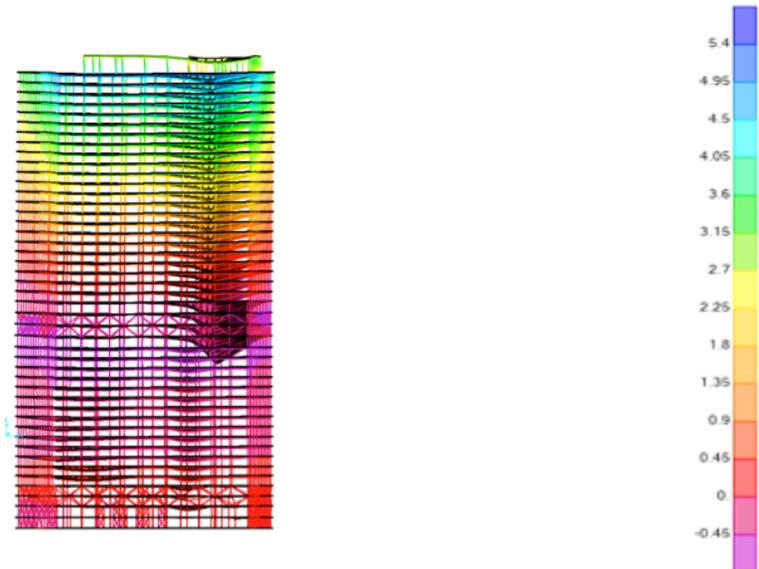
Figure 4.4 Columns 79, 80, and 81 are removed from Floor 21 to Floor 29. The building tilts to the east 5.4 inches. The penthouse does not collapse, though penthouse deflection increases.

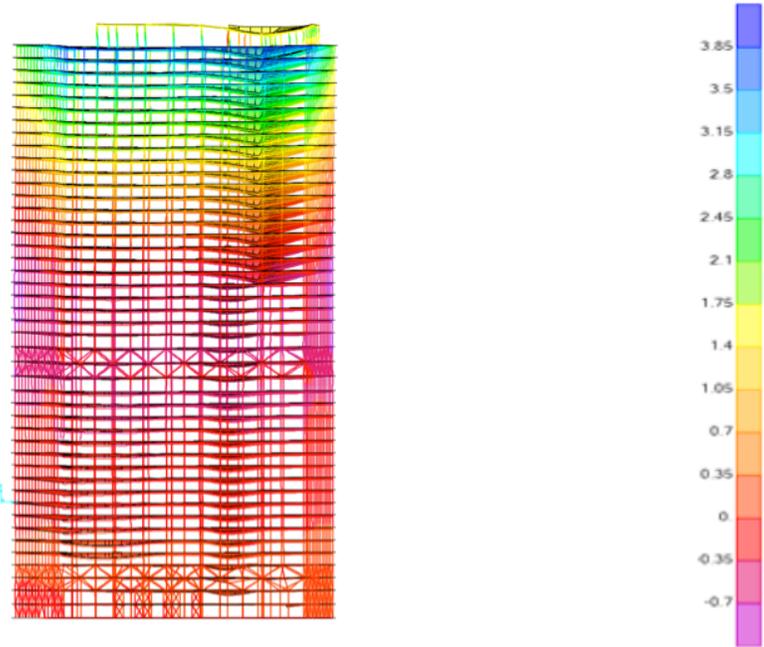
Figure 4.5 Columns 79, 80, and 81 are removed from Floor 29 to Floor 37. The building tilts to the east 3.85 inches. The penthouse does not collapse, though its deflection increases.

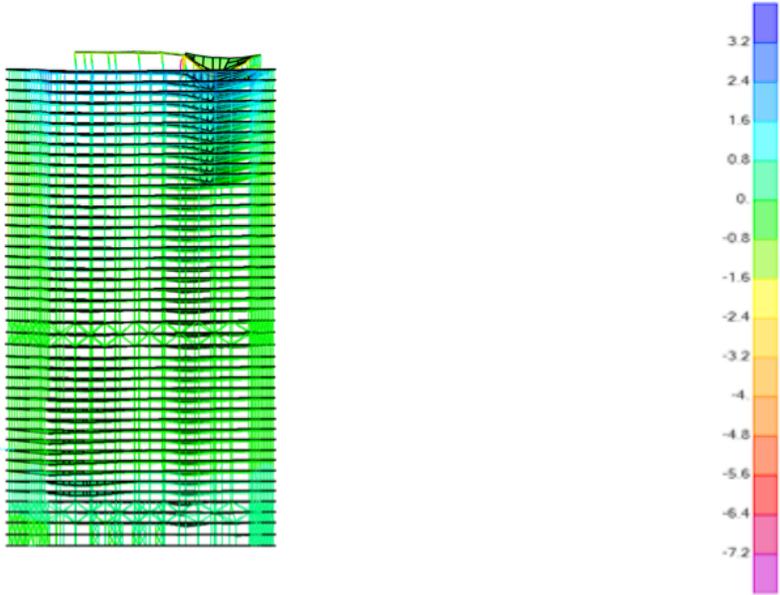
Figure 4.6 Columns 79, 80, and 81 are removed from Floor 37 to Floor 45. Tilting of the building is now negligible, whereas the deflection of the penthouse is now much greater.

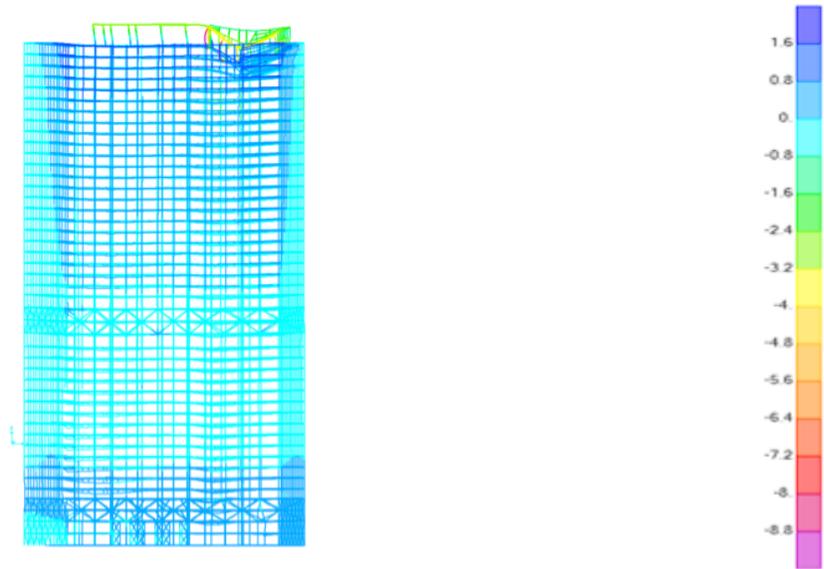
Figure 4.7 Columns 79, 80, and 81 are removed from Floor 45 to the penthouse. Tilting of the building is now negligible. The penthouse now collapses, as demonstrated from the significant amount of deflection given in the figure.

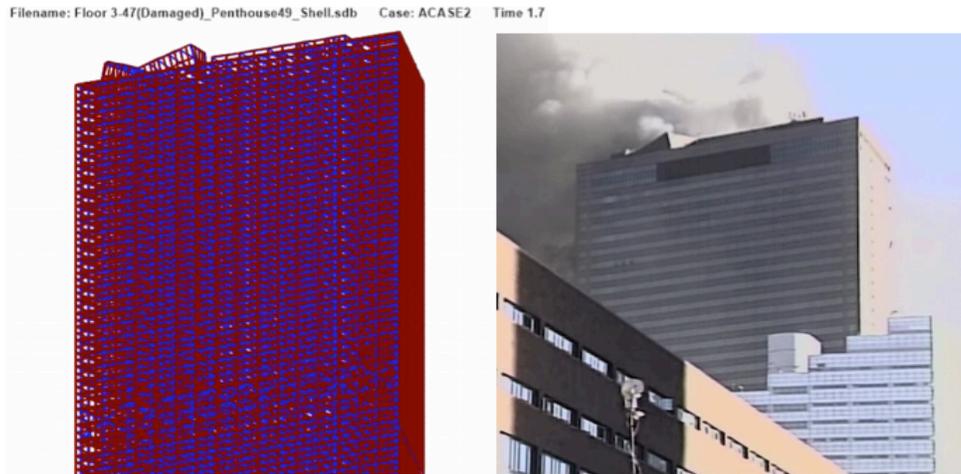
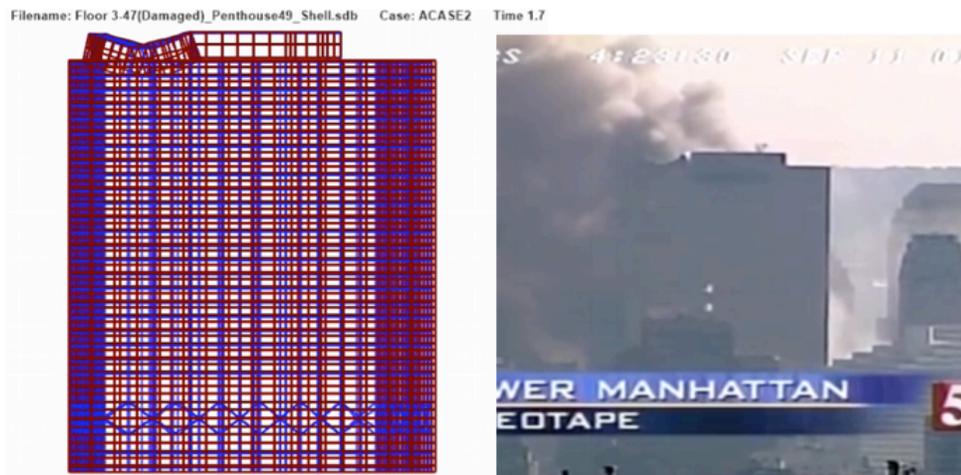
Figure 4.17 (a) Comparison of simulated collapse to perspective 1; (b) comparison of simulated collapse to perspective 2.

Based on this analysis, we found that the simultaneous failure of all core columns followed by the simultaneous failure of all exterior columns produces almost exactly the behavior observed in videos of the collapse. The computer time history model accounted for mass and acceleration during collapse in which an acceleration time dependent function accounted for impact resistance over time. Specifically, the simulated velocity and acceleration of the building in our SAP2000 model, shown in Figure 4.18, matches almost exactly with the motion measured by David Chandler (Chandler, 2010), including the approximately 2.5 seconds of free fall, shown in Figures 4.19 and 4.20 below.
