# **A Structural Reevaluation of the Collapse of World Trade Center 7**

## **Final Report**

**INE Report 18.17**

**March 2020**

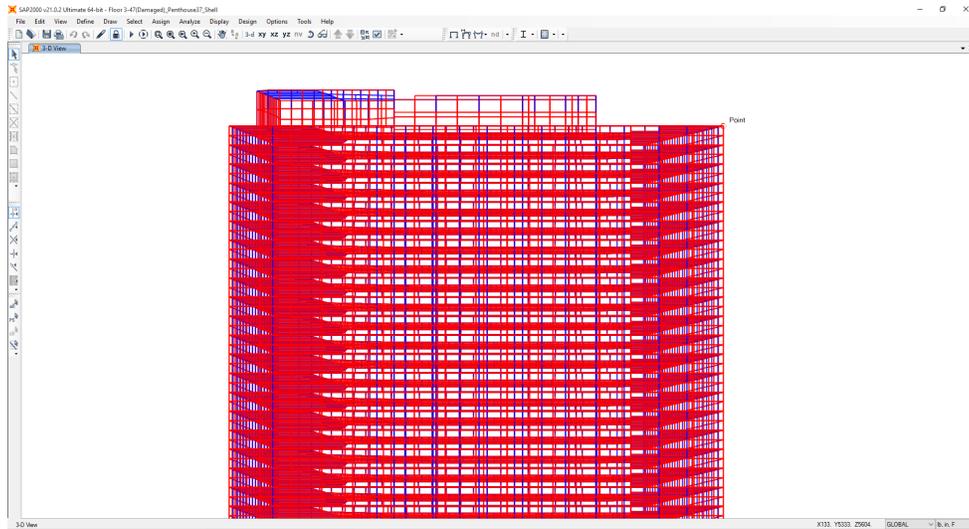
Figure 4.18 UAF Simulation of core column-exterior column failure scenario.

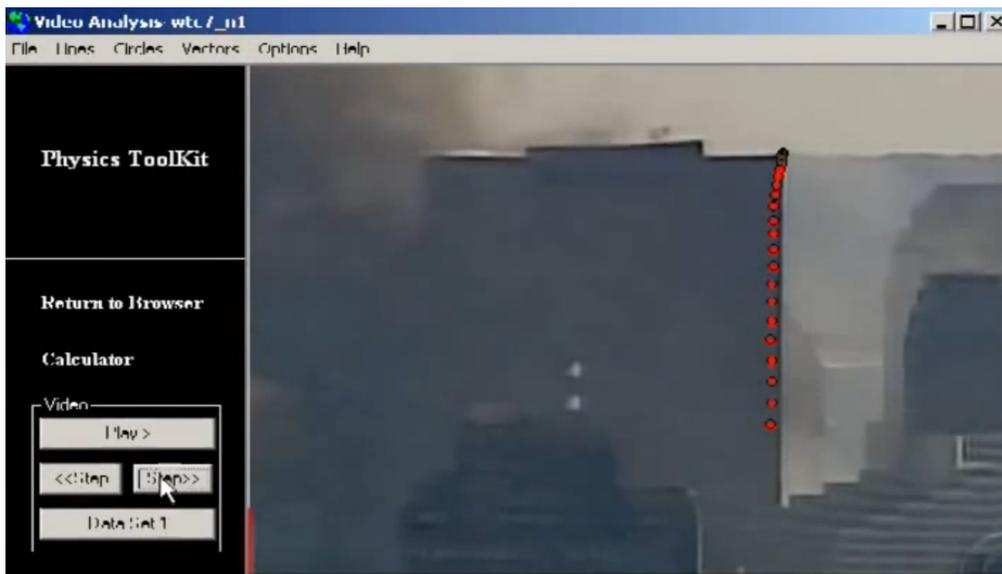
Figure 4.19 Velocity analysis by David Chandler (Chandler, 2010).

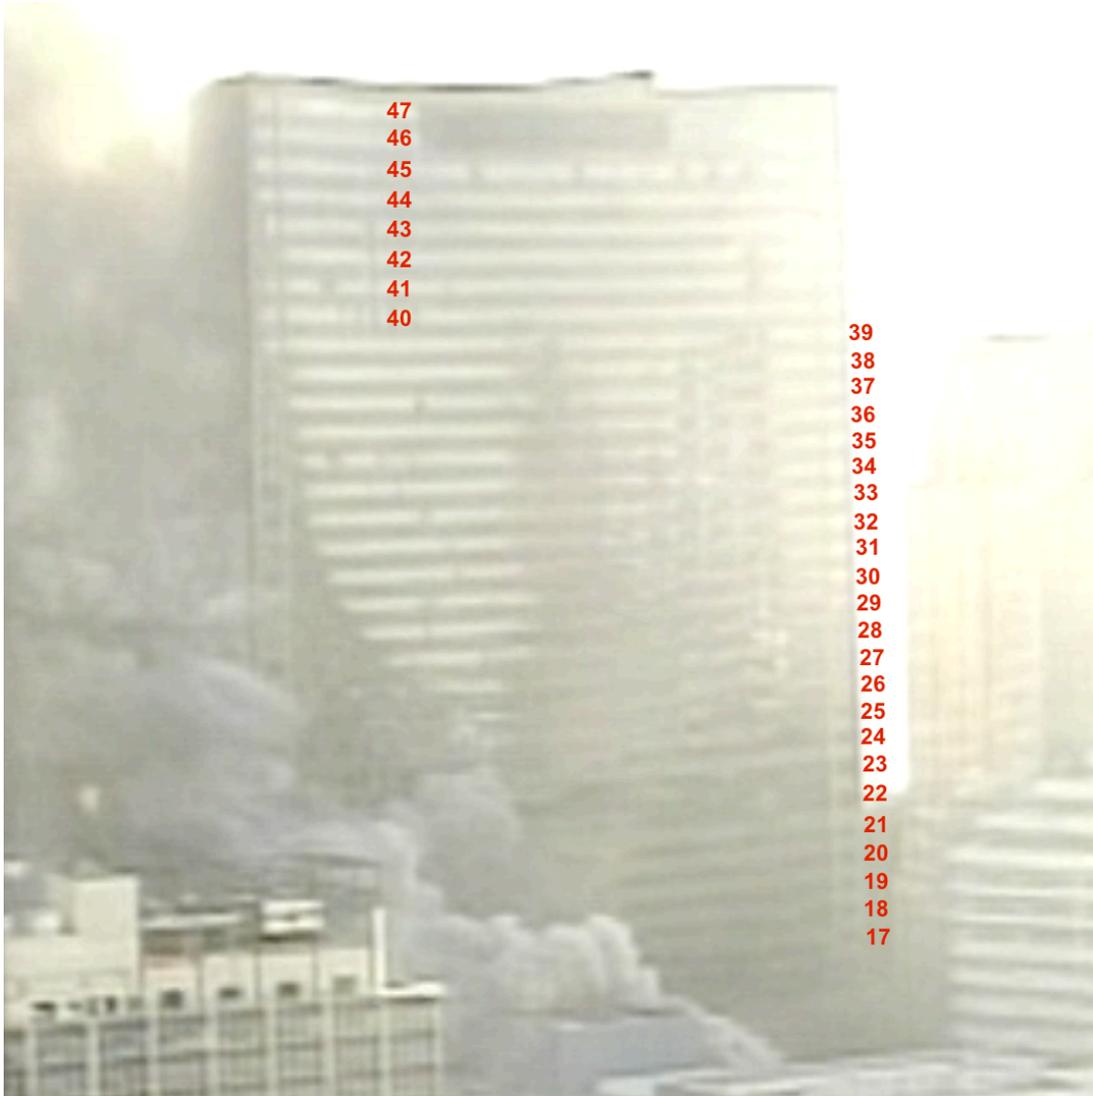
It should be noted that we conducted two separate simulations involving the failure of the core columns and exterior columns over 8 stories: One was the failure of all columns from Floor 12 to Floor 19; the second was the failure of all columns from Floor 6 to Floor 13. The two simulations were identical in terms of the downward velocity and acceleration of the northwest corner at the top of building. We therefore found that the collapse could have started at various floors. Based on our subsequent review of video footage, we found that Floor 16 is the uppermost floor where the collapse could have initiated, because the video shows Floor 17 to Floor 47 falling uniformly as a unit (see Figure 4.21 below). Although some floors below Floor 17 are somewhat visible in the video, it cannot be determined with confidence that they are falling as a unit with the floors above.

Figure 4.21 Floors 17 to 47 falling uniformly as a unit (CBS).
